FREQUENT FAILURE OF CW PUMP, RWP, CTPL MOTORS TOP BEARING

U. M. VISHWAKARMA
A. E. / EM II
KTPS, KORADI

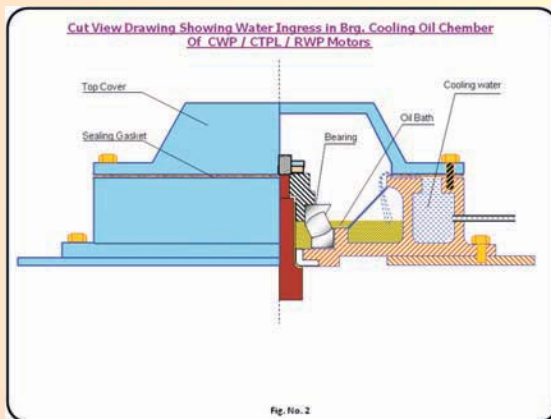
The top cover was removed. Please look at the Fig. No. 2 to see how the housing cover is fitted. At a distance 'B' i.e. 25 mm, the M 12 bolts (12 Nos.) are tightened with gasket. The contact surface 'A' is of 85 mm. but tight fit contact surface of cover is of width 50 mm (i.e. 25 + 25) from the end through out circle. The remaining portion $85 - 50 = 35$ mm width through out the circle of gasket is not so pressed and allows the water to seep in. This water which seeps through the in-pressed area of gasket reaches the oil chamber and contaminates the lubricant oil.

This could be the reason for the fact that the water only tended to flow in side and was not coming out. A circular plate was provided in between the housing and cover which can be fitted both from inside and outside without disturbing the existing condition of housing. Sufficient space was found to insert such a plate.
