**INSPECTION OF DAMAGED /RUNNING/FAILED PARTS
CHPA/B/C of Unit 3 to7**

**M/s. CHANDRAPUR SUPER THERMAL POWER
STATION,MSPGCL,CHANDRAPUR**

***CENTRAL POWER RESEARCH INSTITUTE
THERMAL RESEARCH CENTRE,DHUTI– 441108,
DIST.-NAGPUR (M.S.)***

TEST REPORT NO. & DATE	: TRC/EMD/TOS-290/2022-23/FR Date 18.03.2023
CLIENT'S ADDRESS	: Chief Engineer, Chandrapur Super Thermal Power Station, Maharashtra State Power Generation Co. Ltd., Chandrapur. (M.S.)
WORK ORDER NO.	: email dtd. 03.03.2023
PARTICULARS OF COMPONENT INSPECTED	: Components CHPA/B/C of Unit 3 to7
PERIOD OF INSPECTION	: 16.03.2023-18.03.2023
PARTICULARS OF INSPECTION	: Inspection of damaged /running/failed parts at CHPA/B/C of Unit 3 to7
TEST IN ACCORDANCE WITH STANDARD/SPECIFICATION/ CLIENTS REQUIREMENT	: As per client's requirement.
DEVIATION IF ANY	: NIL
NUMBER OF PAGE	: 53 Pages.(Fifty Three pages only)

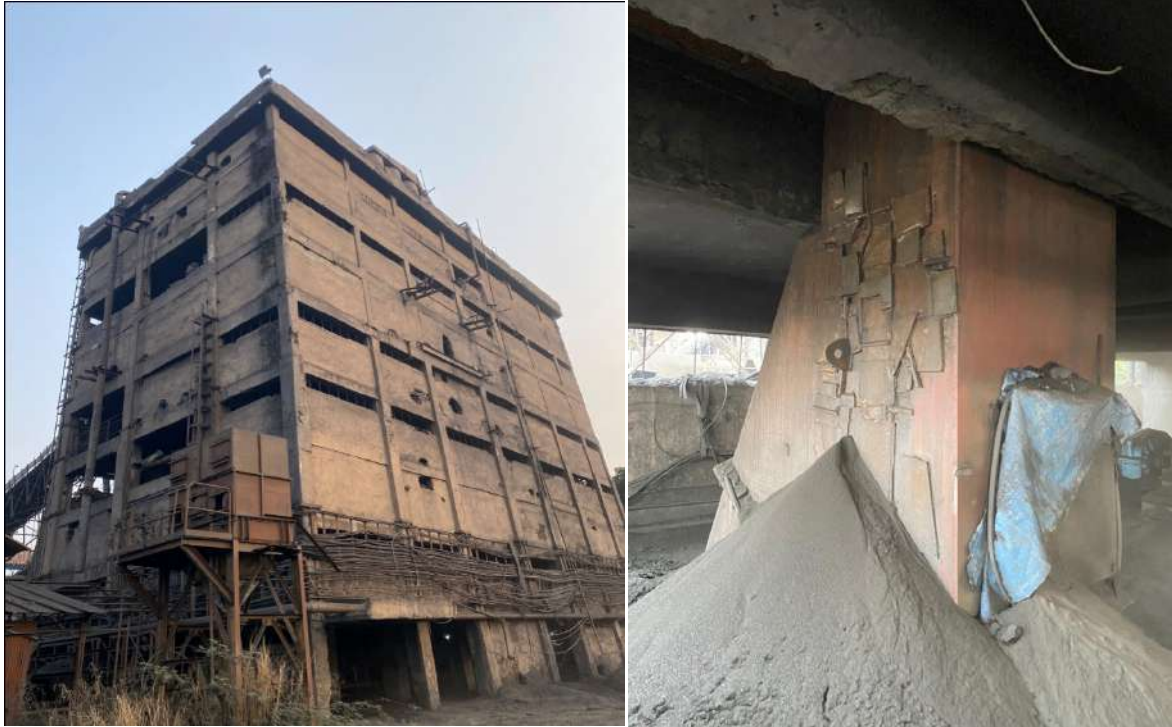
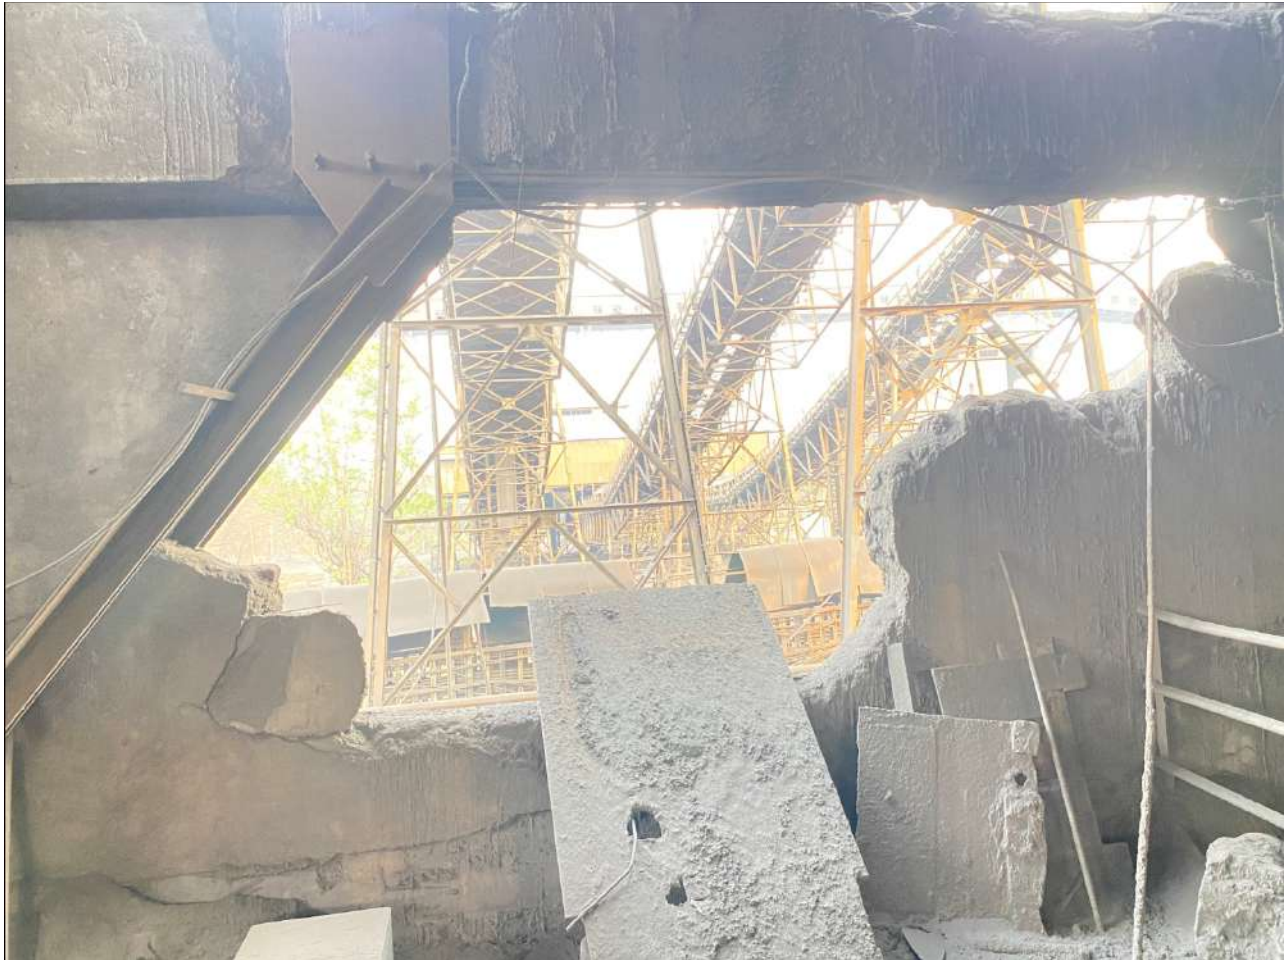
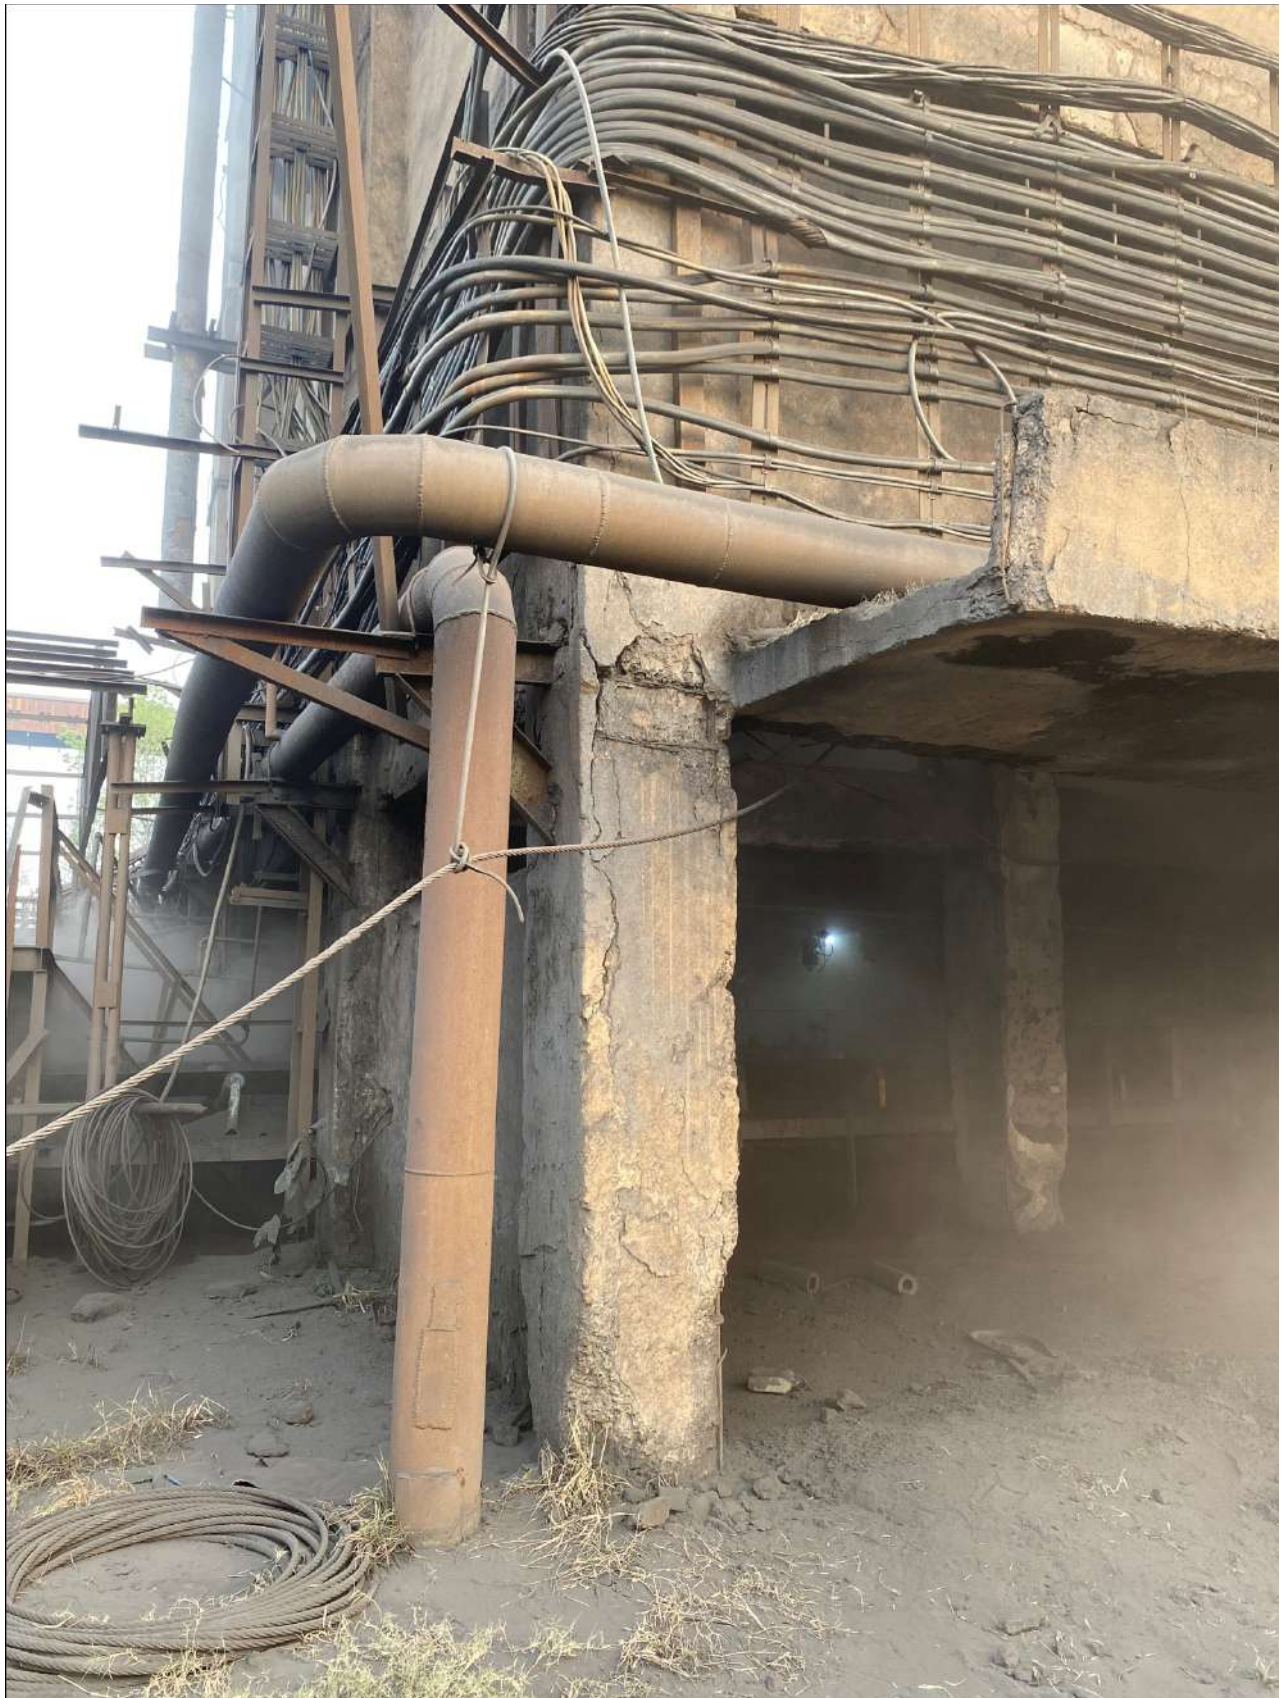
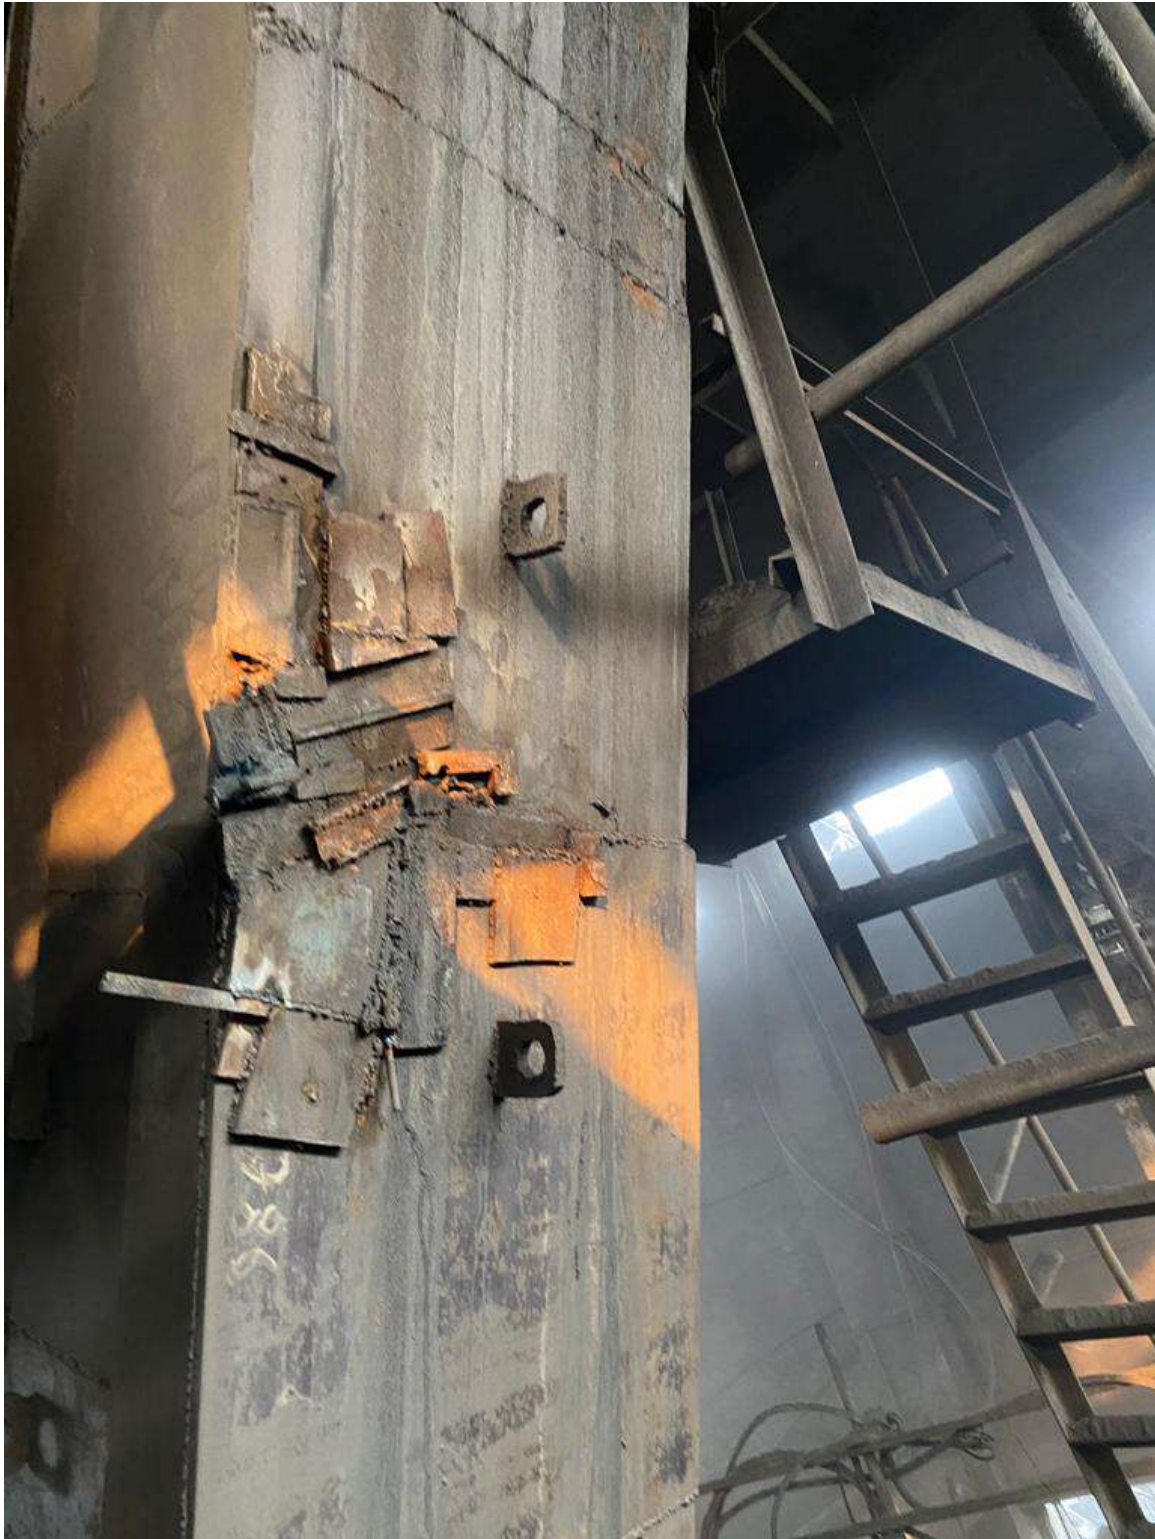
4.1 Crusher House of CHPA of Unit 3&4:

The crusher house of CHPA of Unit 3&4 was inspected. Three nos. of Coal Crushers with vibrating screens are installed for crushing of raw coal received from various coal mines. Other allied auxiliaries are installed at various elevations on complete steel structure of crusher house. All installed auxiliaries are in service since commissioning in 1986 and its structure & it's supporting bracing are badly corroded. Many times, repairing/reconditioning & strengthening work done earlier. Vibration level at Crusher House is also noted at higher level. Due to long service i.e., more than 36 years the crusher conveyor structure is subject to rust and wear out mainly due to aging effect and rust prone environment working condition in CHP area.

Many times, repairing/reconditioning & strengthening work done earlier and now it is beyond repairable. Vibration level at Crusher House is also noted at higher level need urgent modification/modernization/strengthening to avoid secondary failures

In view of observation at crusher house, it is recommended to undertake the suitable concrete major renovation/modification works in installed equipment's in crusher house to enhance the life of Crusher House and for safe & smooth operation of all equipment's to avoid any unforeseen incidence in future.

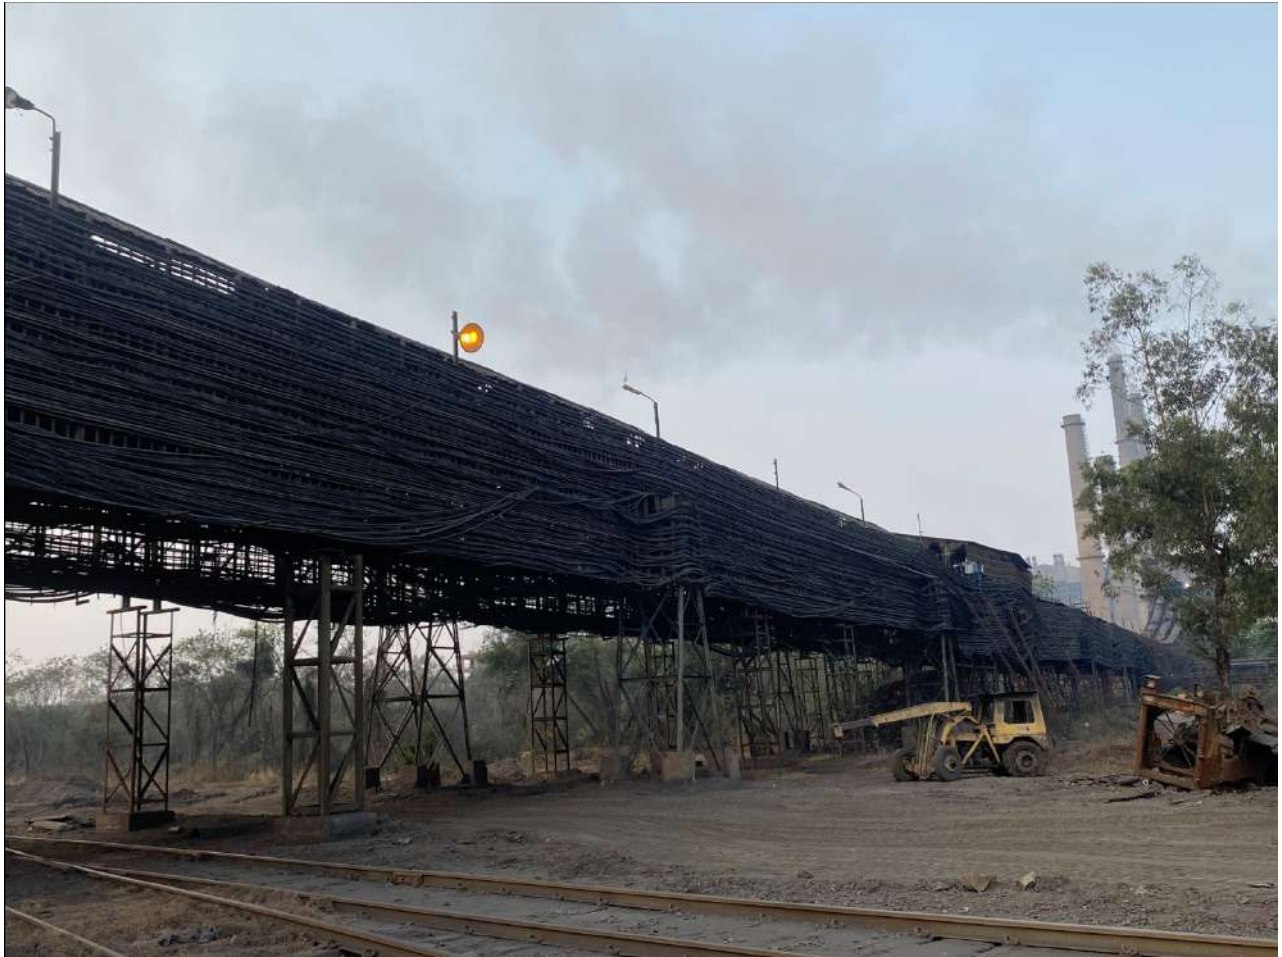
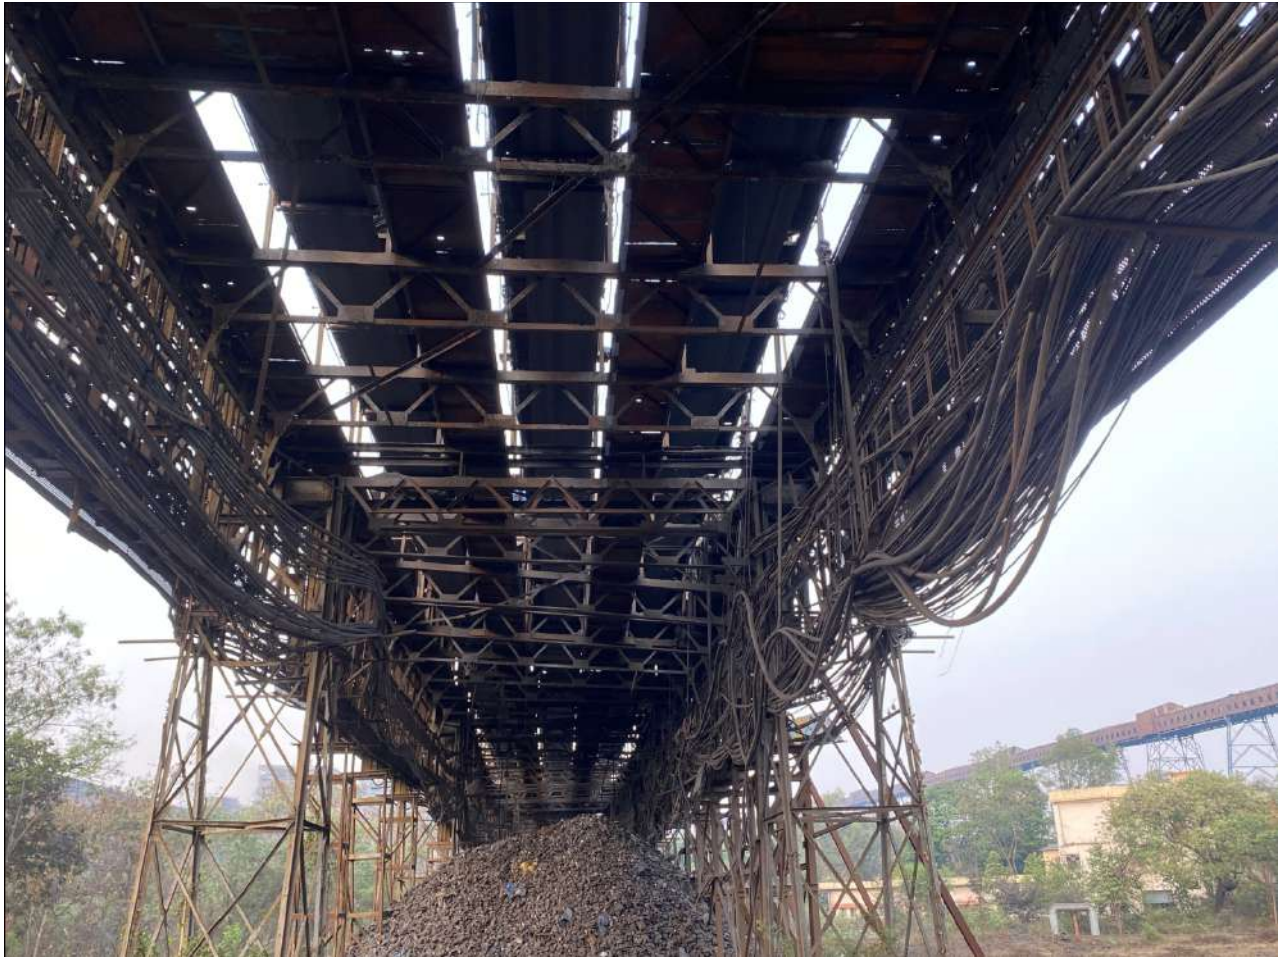
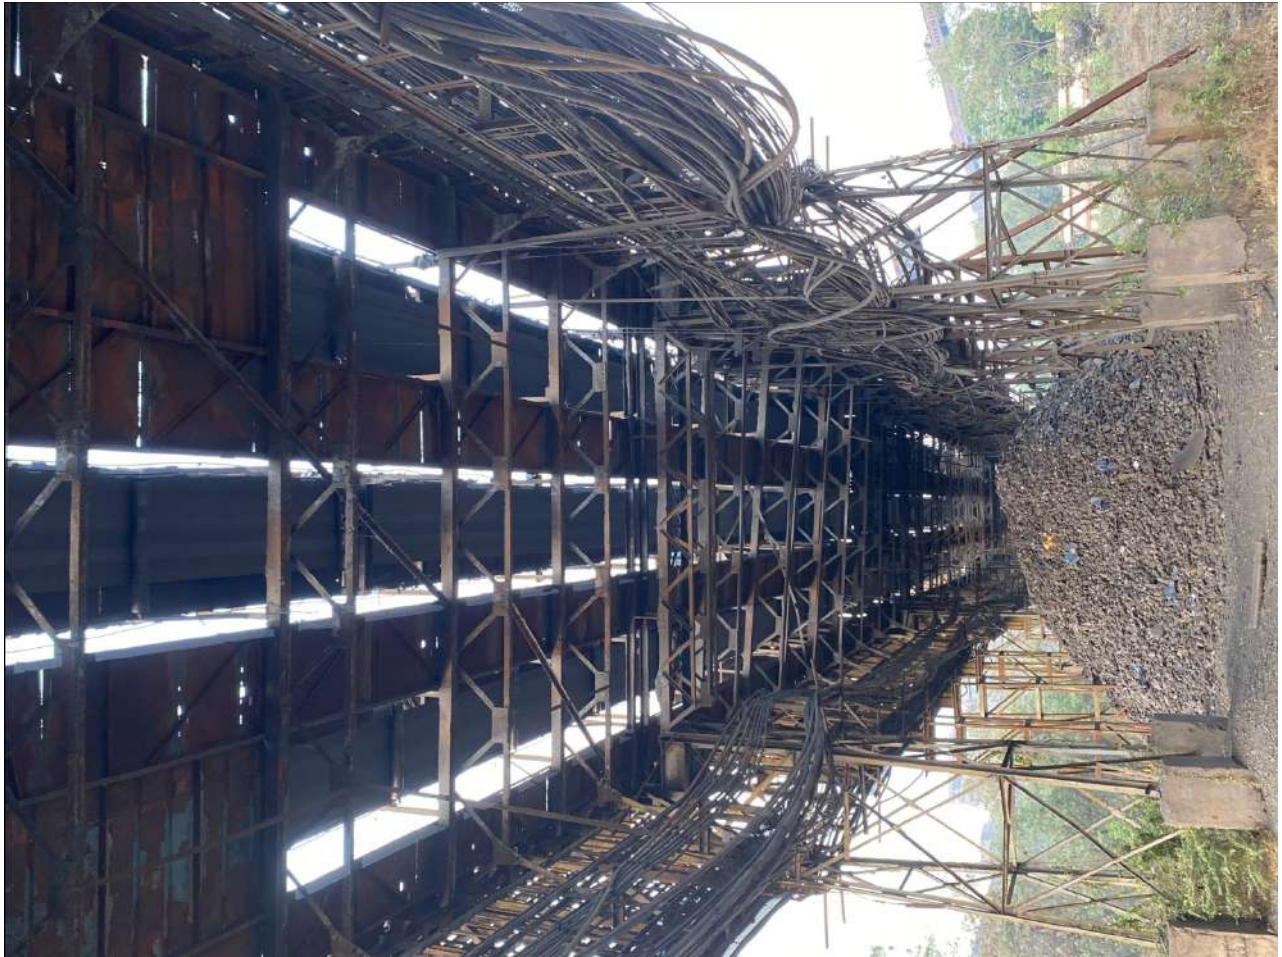
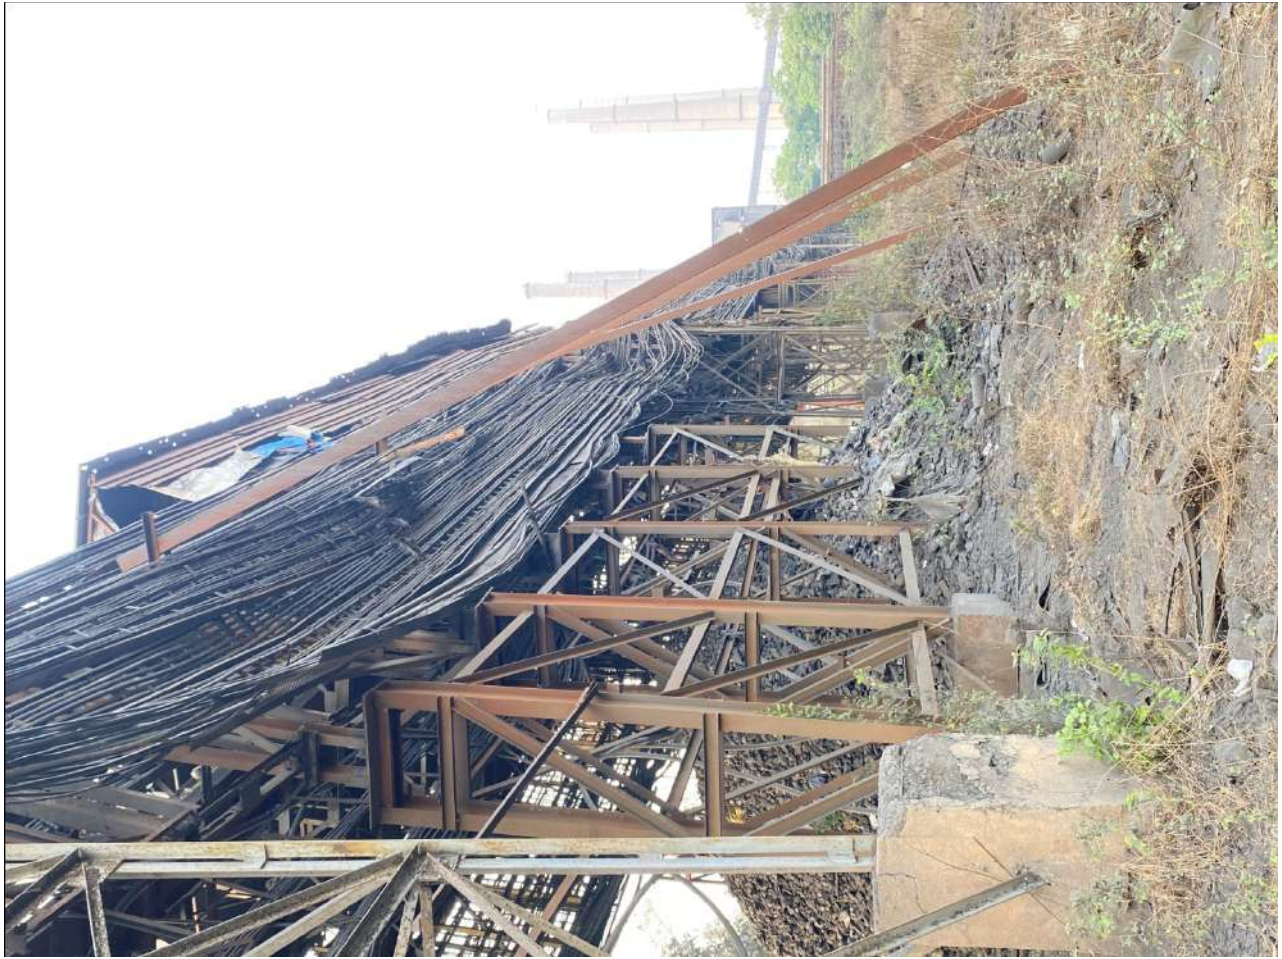
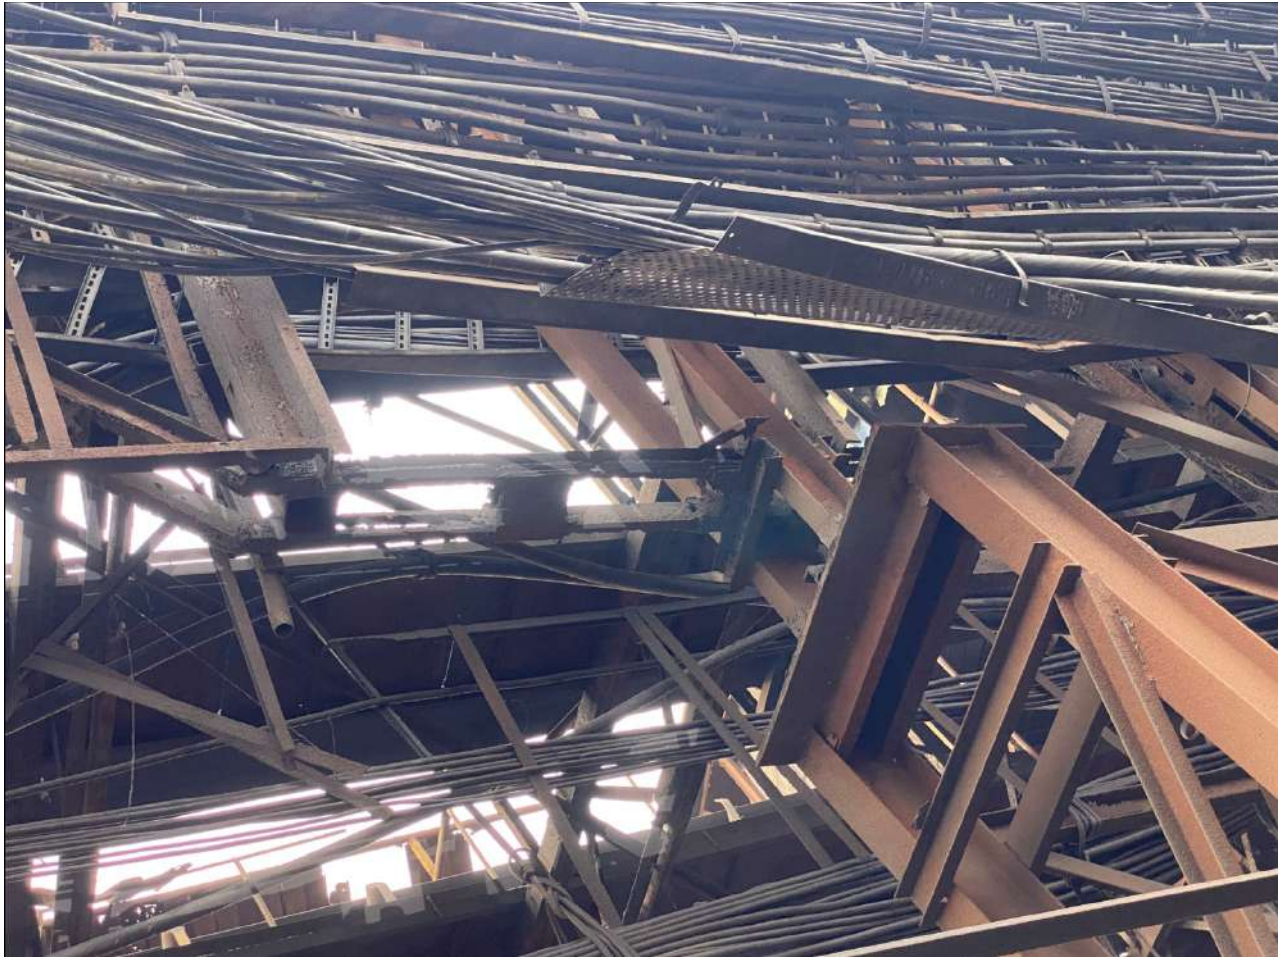
4.2 Belt Conveyor 10A/B/C of CHPA of Unit 3&4

Belt Conveyors BC- 10A/B/C are the critical conveyors, any failure or breakdown may lead to generation loss. These conveyors are located near to coal reject yard having high sulfur fumes due to which belt conveyor steel structures are subjected to heavy rate of rusting. As per visual survey, it is observed that conveyor steel structures are badly rusted at several locations. Conveyors trusses supporting conveyor belt floor are apparently highly corroded and top member of N trusses are showing extensive deterioration. After rendering the more than 36 years of service, sign of deterioration were observed in the form of collapsing walkway, increased deflection of N trusses between towers due to extraordinary loads of electric cables they are made to support, extraordinary corrosion of cross member supports, broken cross bracing and structural member of tower supporting conveyor belts. The vertical gantry supports & bracing are damaged or dislocated at many places. This led to the misalignment of the deck channel structure which further led to the running out problem of conveyor belts 10A/B/C.

In past strengthening or repairing of the above conveyors structure has been done, but now it is beyond repairable and its post dislocated from concrete foundation. Hence it is recommended to take up the work of Renovation/Upgradation/Modification of Belt Conveyor 10A/B/C with allied works on urgent basis in CHPA, so that bunkering conveyor stream BC 10A/B/C will run sustainable capacity.

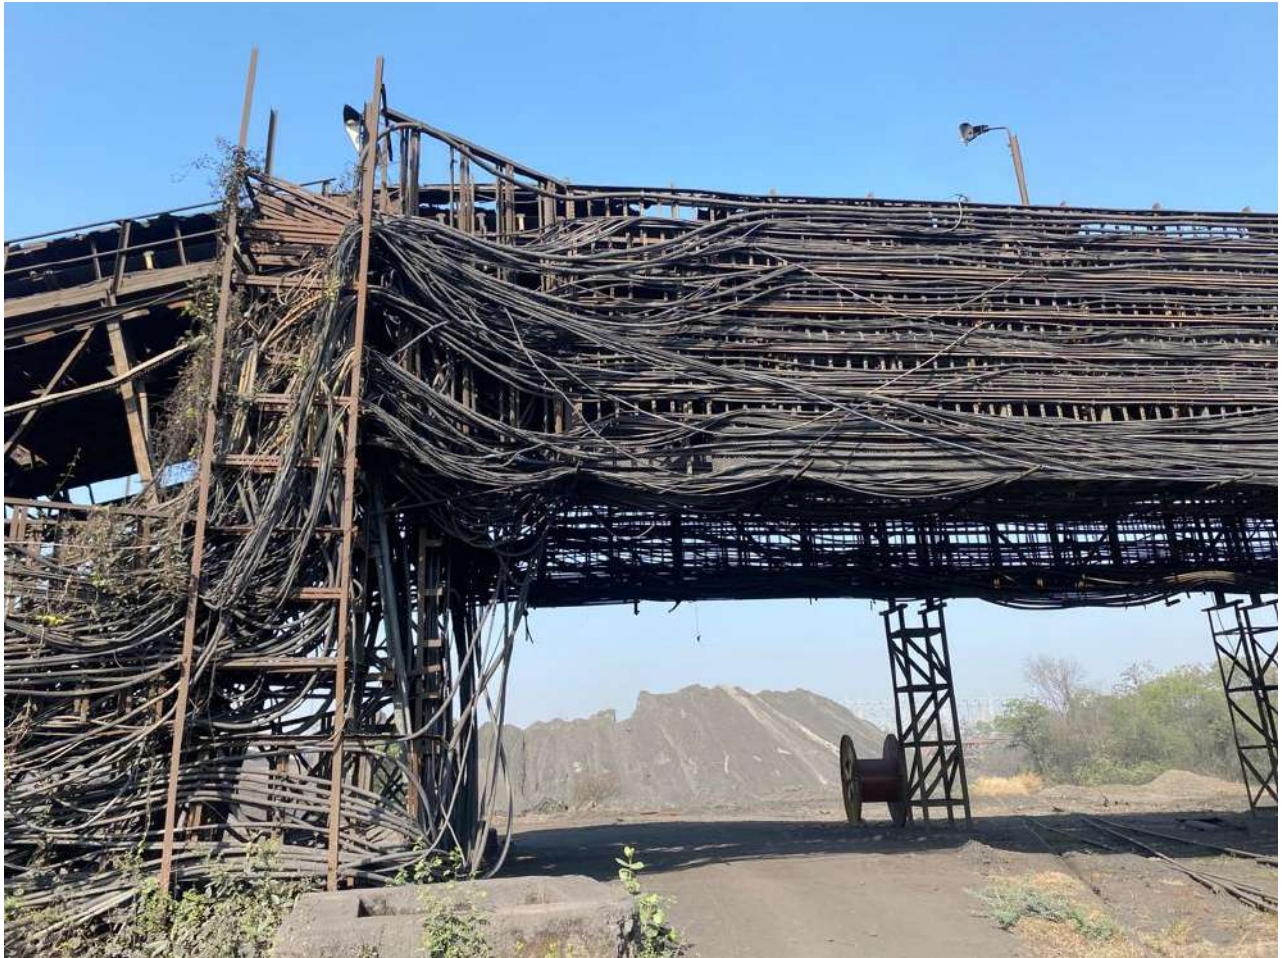
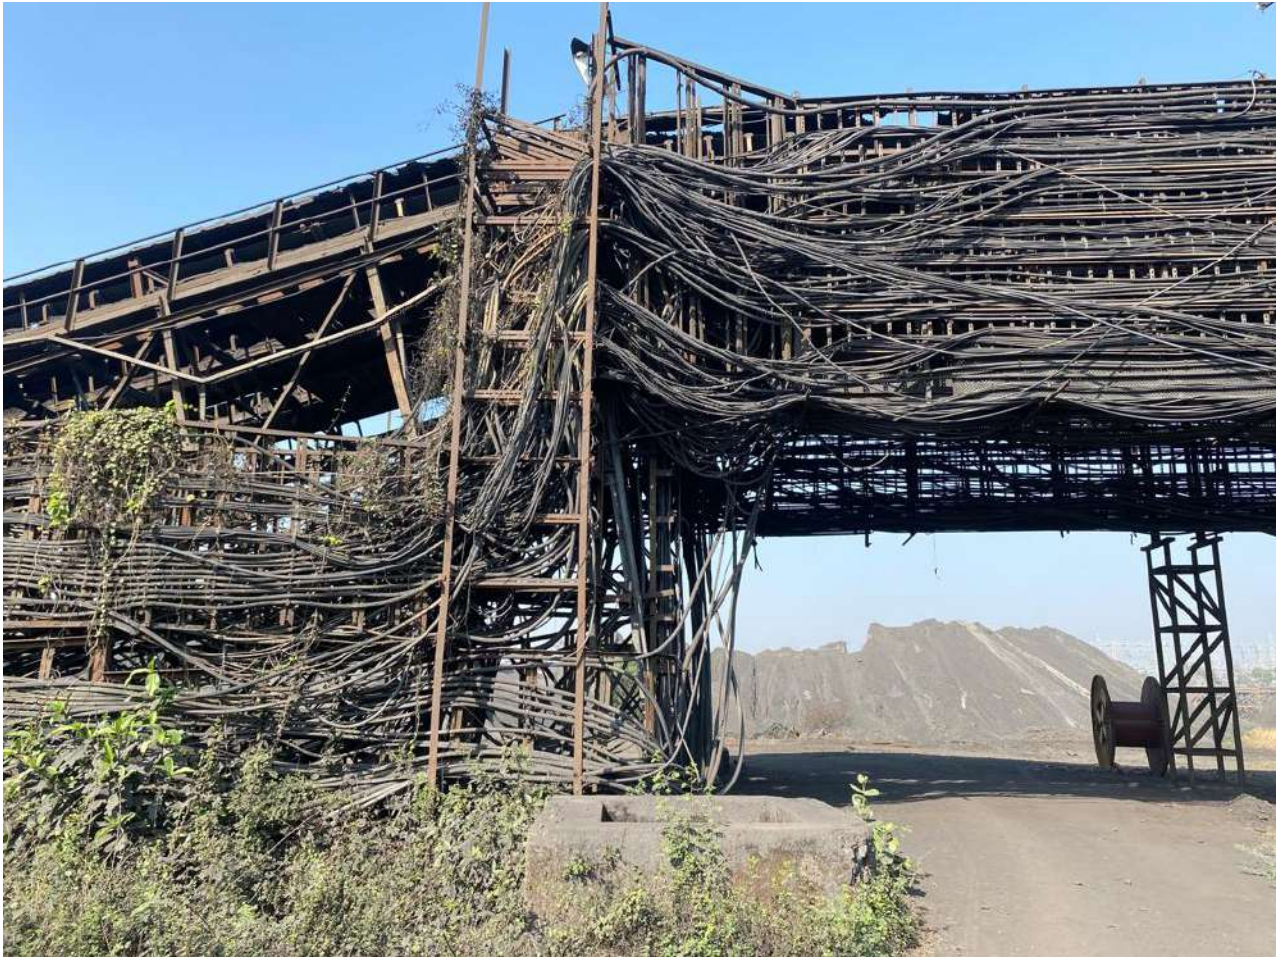
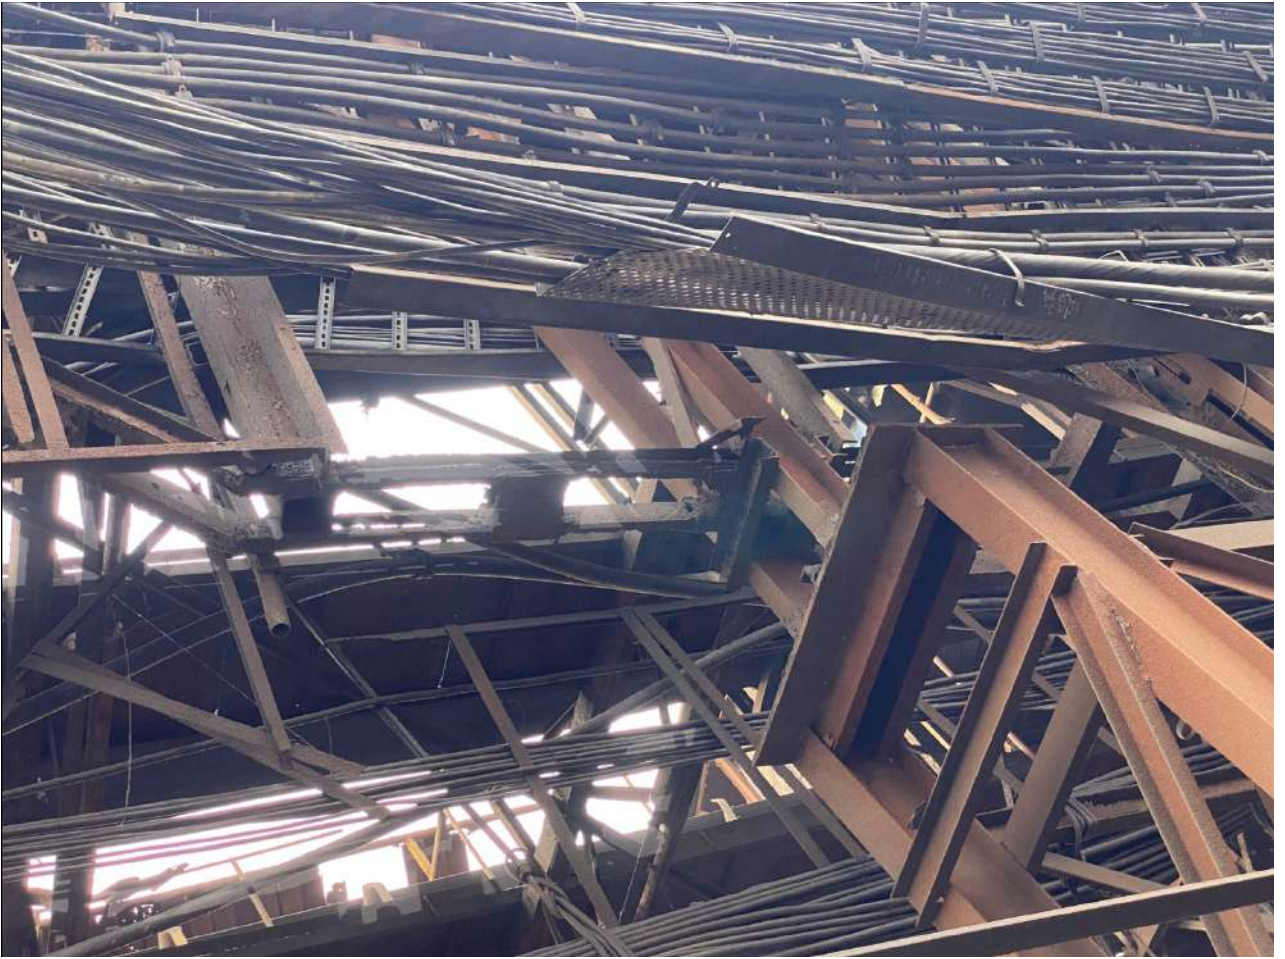
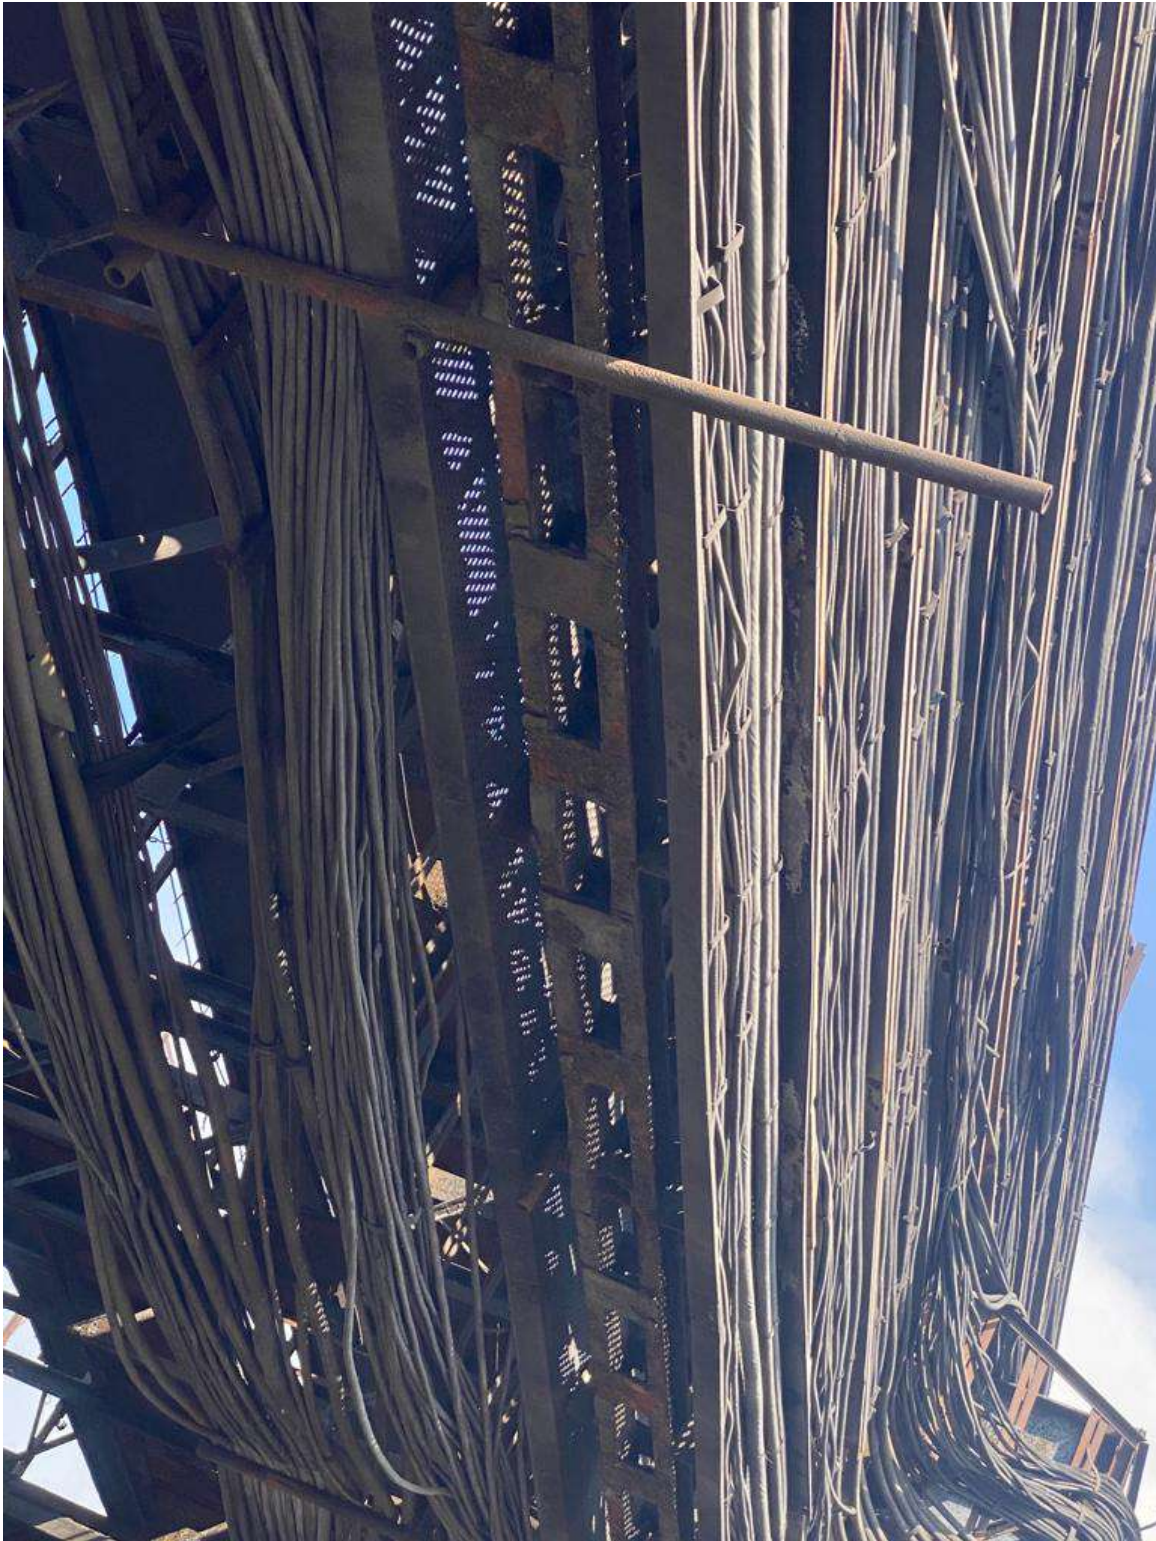
4.3 Conveyor cable of 10 A/B/C of CHPA of Unit 3&4:

At present conveyor cable are installed along both side of conveyor gantry structure which increases the load on conveyor gantries. Further, in past major breakdown was occurred at belt conveyor 10A/B/C in which conveyor gantry structure was buckled at some locations. On thorough inspection it is due to the long service of more than 36 years & aging effect and all overweighed conveyor cable, the conveyor gantry is under danger zone

Considering importance of BC 10A/B/C as main bunkering streams and comes under generation path & safety point of view it is recommended for Modification/Modernization of conveyor cable of 10 A/B/C of CHPA in which unwanted excess cables (Unit 1&2 are decommissioned) may be

removed permanently and running existing cable may installed on separate New structure for smooth generation of Unit 3&4 sets.
