**INSPECTION OF DAMAGED /RUNNING/FAILED PARTS
CHPA/B/C of Unit 3 to7**

**M/s. CHANDRAPUR SUPER THERMAL POWER
STATION,MSPGCL,CHANDRAPUR**

***CENTRAL POWER RESEARCH INSTITUTE
THERMAL RESEARCH CENTRE,DHUTI– 441108,
DIST.-NAGPUR (M.S.)***

TEST REPORT NO. & DATE	: TRC/EMD/TOS-290/2022-23/FR Date 18.03.2023
CLIENT'S ADDRESS	: Chief Engineer, Chandrapur Super Thermal Power Station, Maharashtra State Power Generation Co. Ltd., Chandrapur. (M.S.)
WORK ORDER NO.	: email dtd. 03.03.2023
PARTICULARS OF COMPONENT INSPECTED	: Components CHPA/B/C of Unit 3 to7
PERIOD OF INSPECTION	: 16.03.2023-18.03.2023
PARTICULARS OF INSPECTION	: Inspection of damaged /running/failed parts at CHPA/B/C of Unit 3 to7
TEST IN ACCORDANCE WITH STANDARD/SPECIFICATION/ CLIENTS REQUIREMENT	: As per client's requirement.
DEVIATION IF ANY	: NIL
NUMBER OF PAGE	: 53 Pages.(Fifty Three pages only)

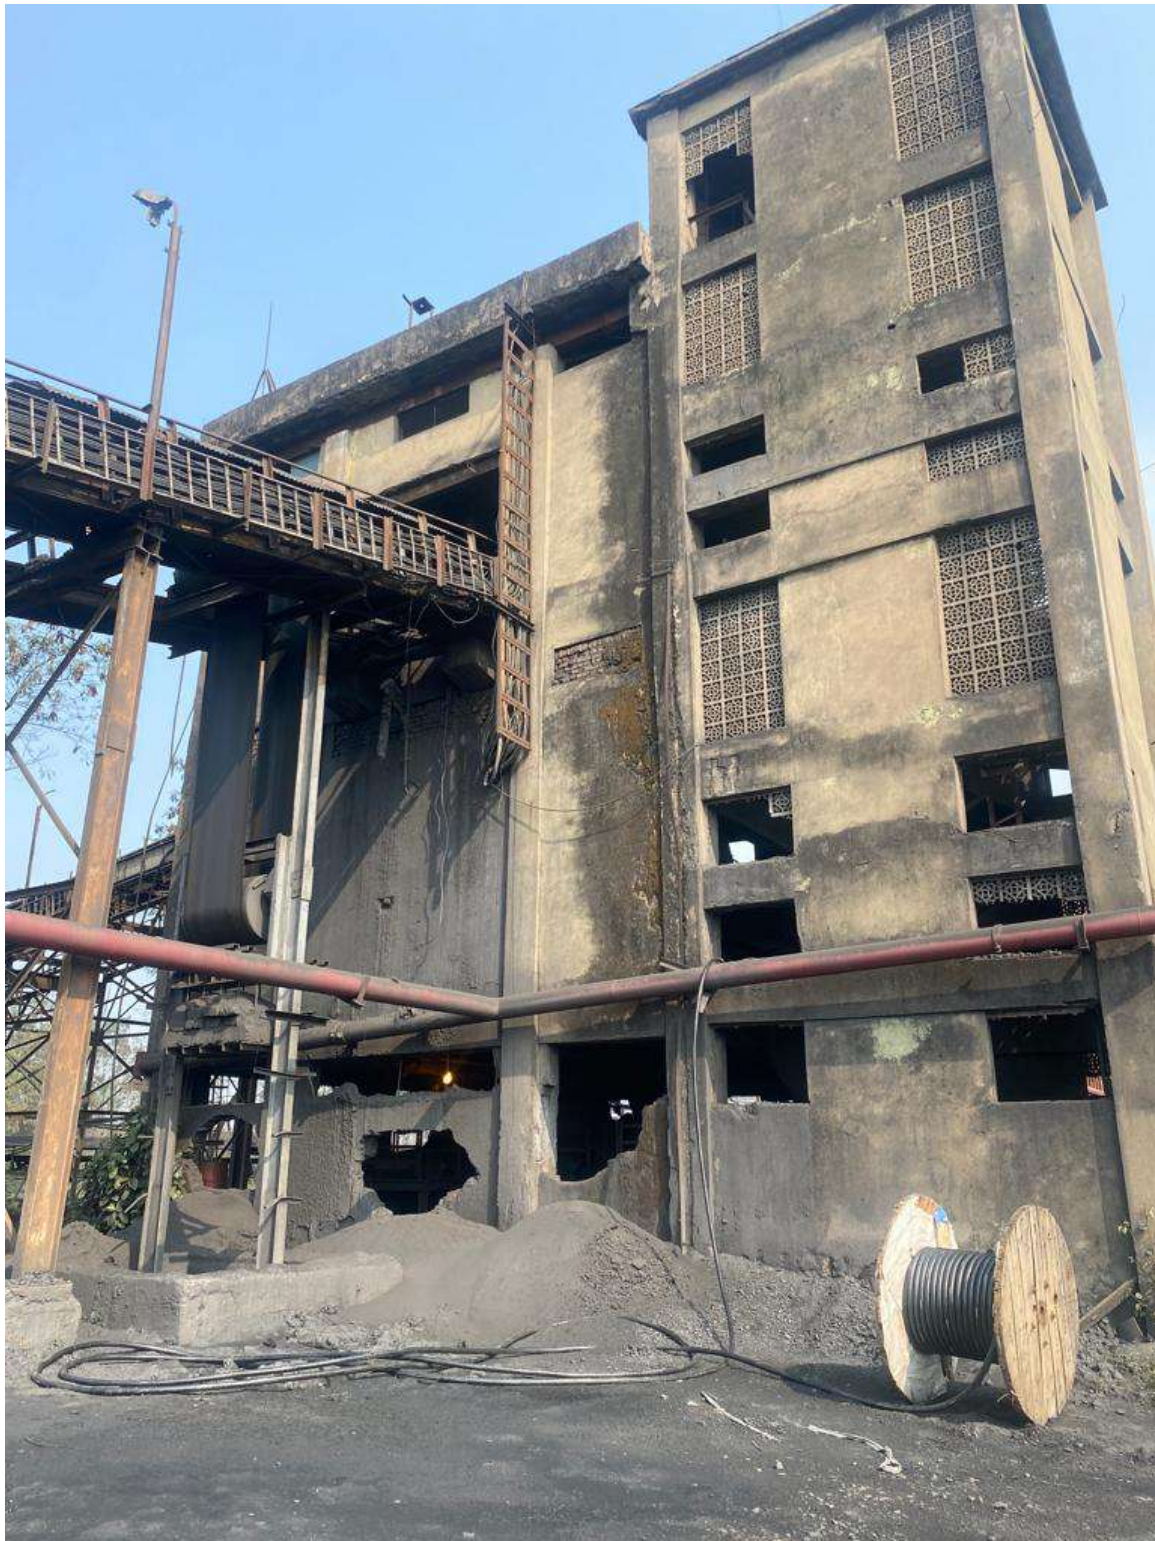
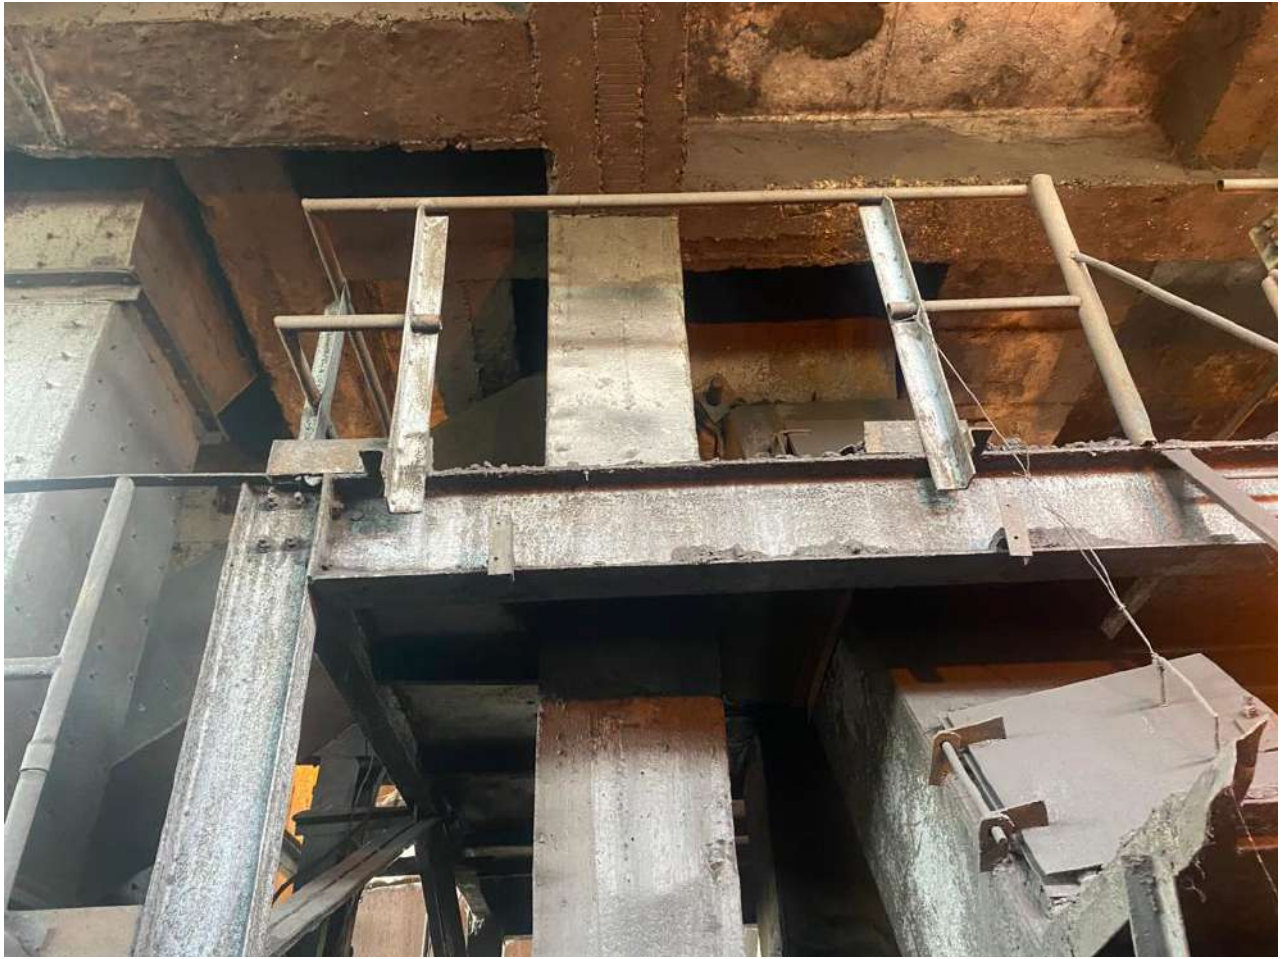
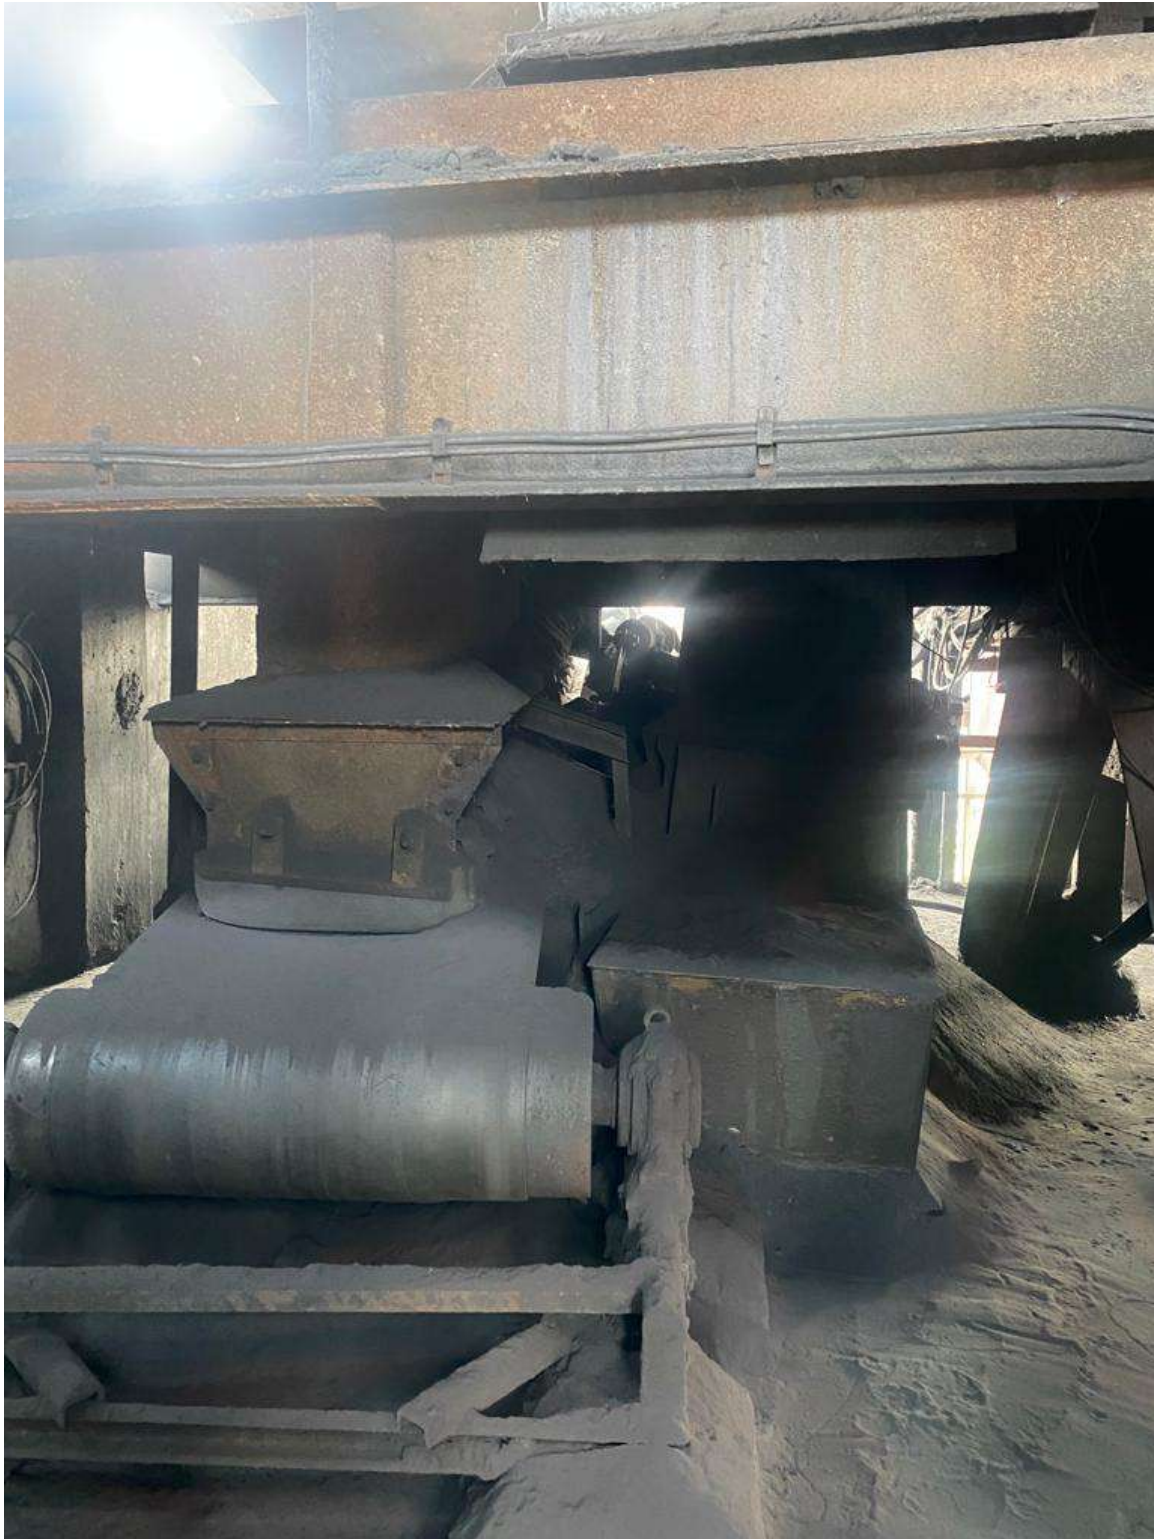
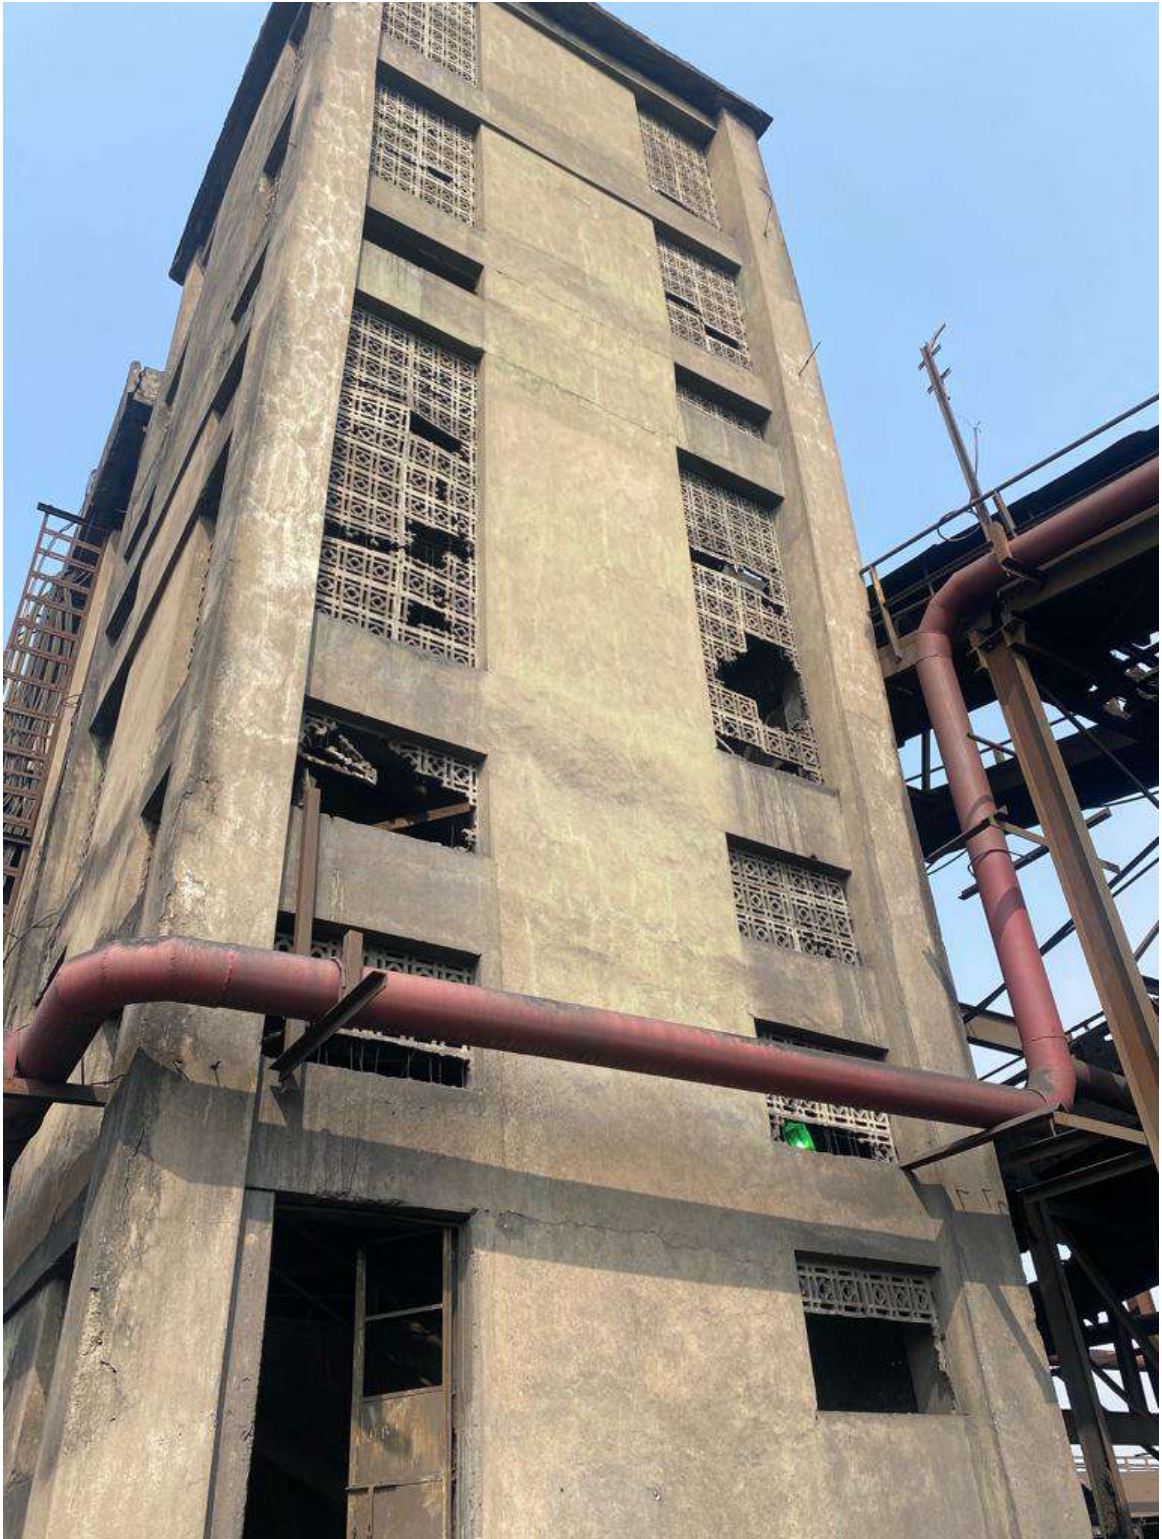
4.4 Bypass chute with hydraulic cylinder at JT-08 of CHPA of Unit 3&4:

JT-08 (Junction Tower) is installed where reclaiming conveyor streams BC 23A/B/C are provided to receive coal from Elecon stacker through BC 22B and DRCC reclaiming through BC 21B. Various multiple chutes & flap gates are installed at JT-08 through which coal from BC 21B & BC 22B transported to bunkering streams. However, there is some limitation like BC 21B (DRCC conveyor) delivered coal only on BC 23A or BC 23B not in BC 23C and BC 22B (Elecon conveyor) delivered coal only on BC 23B or BC 23C not in BC 23A. Due to these limitations, generation loss occurred for unit 3&4. Further BC 119 is installed at JT-08 as a priority conveyor to transport the coal from Elecon reclaiming conveyor through BC 22B to Unit 5,6&7. Hence JT-08 play very vital role to maintained the bunker level of Unit 3&4. Due to long service life i.e., more than 36 years & aging effect, existing JT-06 structures are rusted at many location and concrete structures also dislocated. The repairing / refurbishment / strengthening also done in past. At present, coal stacked at Elecon stack yard is being utilized for CHPB by feeding the coal to bunkers of Unit 5,6&7 via BC 119 in JT-08. In case, there is shortage of coal at CHPB stack yard or there is problem of Stacker Reclaimer for reclaiming purpose and no coal rakes for unloading to bunkered, then there may be generation loss to Unit 5,6&7 on account of poor coal bunkering. Further, coal stacked at DRCC stack yard is needs to be feed from BC 21B to BC 119. So, feasibility is checked to interconnect stack pile of DRCC of CHPA to CHPB so that there will be additional alternatives to feed the coal to Unit 5,6&7 bunkers of CHPB. This will help for reduction in demurrage charges by unloading N-box wagon at CHPA wagon tippler on regular basis, to maintain the bunker level of Unit 5,6&7. Accordingly, bypass chute arrangement & hydraulic actuator system may be installed at DRCC discharge chute of BC 21B to utilized coal for Unit 5,6&7

In view of above, to utilize the infrastructure of CHPA to its full extent, to use the excess coal stacked in CHPA, for better performance of Coal handling plant in terms to avoid generation loss and reduction in rake detention time it is recommended for Design, Engineering, Supply, Erection and commissioning of bypass chute with hydraulic cylinder & modification/renovation at JT-08

for smooth running of coal handling plant for smooth generation of Unit 3 to 7 and fast unloading of wagons at CSTPS Chandrapur.

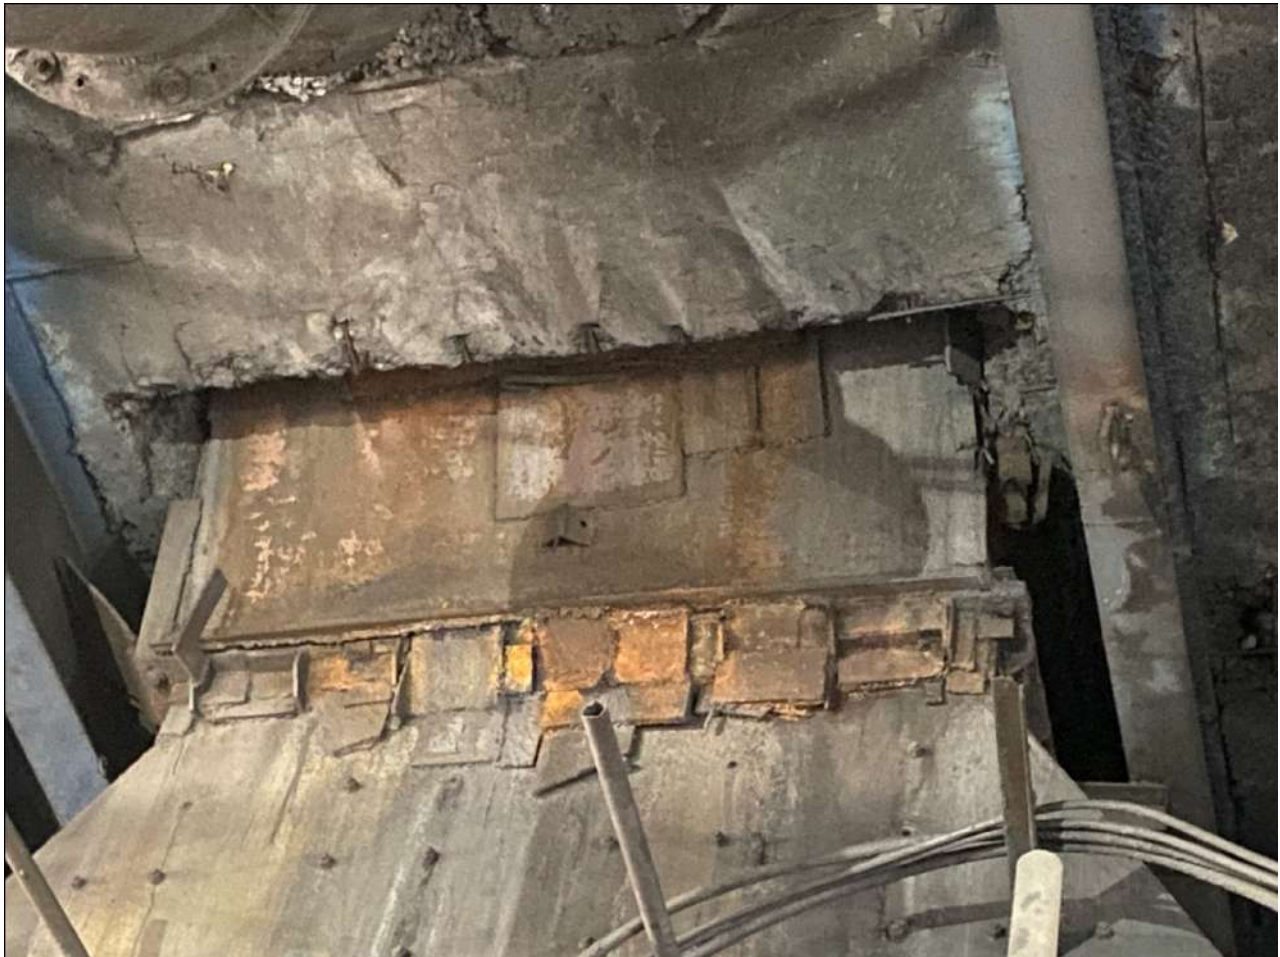
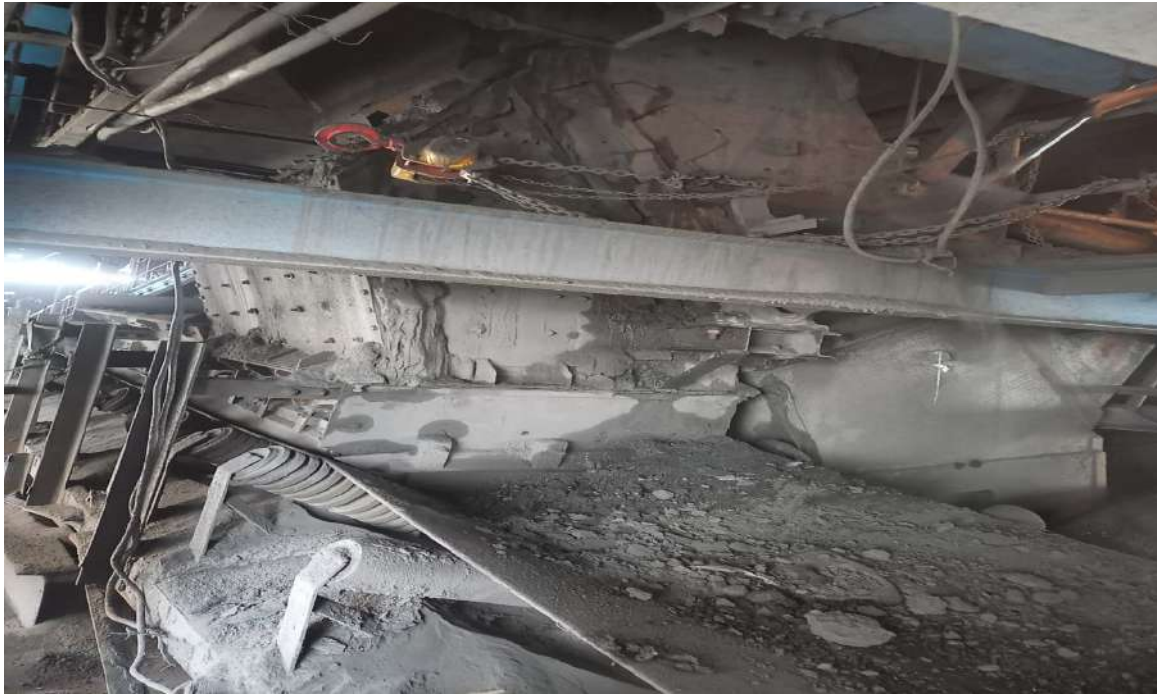
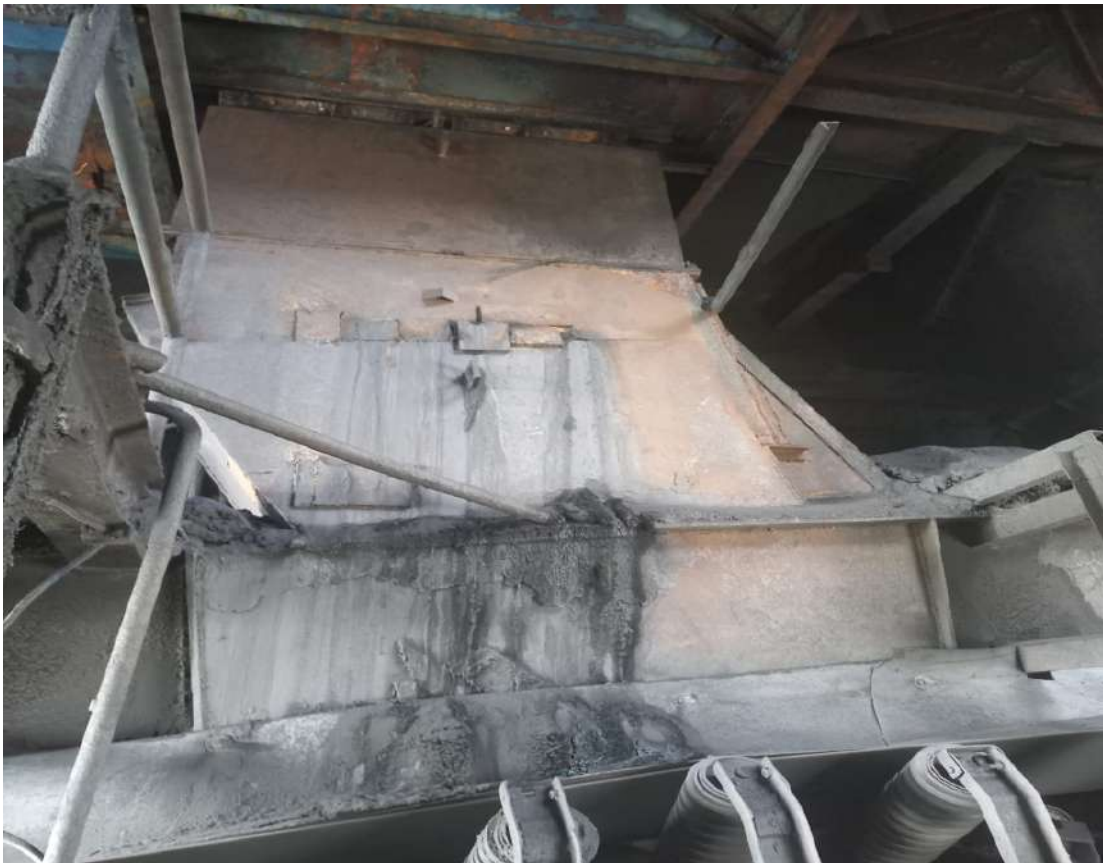
4.5 Wear Resistance Chutes for Belt Conveyor System at CHPA/B of Unit 3to9:

The various conveyor discharge/receiving chute & other auxiliaries skirt board is under unloading zone are subjected to heavy impact and abrasion due to transportation of ROM coal received from various coal mines. It is observed that back/side plates of receiving/discharge chutes are worn out. On the inspection of chutes of CHPA & CHPB, it is observed some conveyor chutes are worn out heavily and resulted into frequent coal leakages. Repeated patching works were carried out on the chutes as per history records.

Due to repeated patching & other work, these chutes are beyond repairable and need replacement on urgent basis to avoid secondary damages to costly conveyor system and to avoid hampering the unloading of 'N' box wagons. Hence to avoid coal spillage and to ensure smooth operation of coal handling plant, timely replacement of these chutes plates with suitable wear plates of sufficient hardness & suitable material composition is required as per wear pattern & coal flow trajectory.

In view of above and to ensure higher availability of unloading system for smooth running of coal handling plant, it is proposed for Design, Engineering, Supply, Erection and Installation of Wear Resistance Chutes for Belt Conveyor System at CHPA/B of Unit 3to9 of CSTPS Chandrapur.

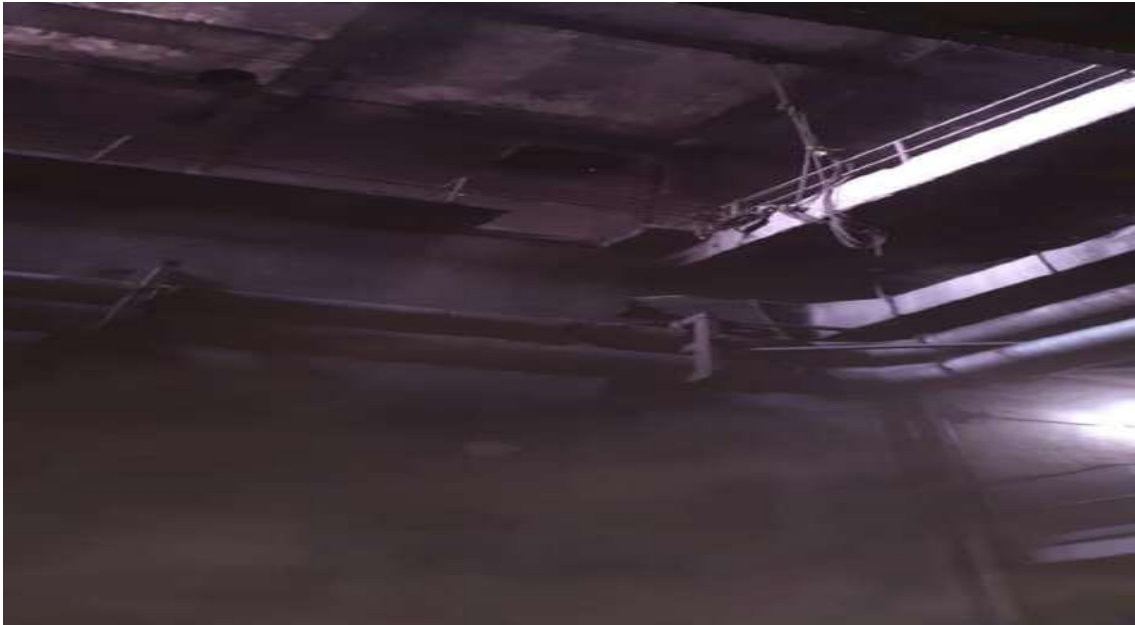
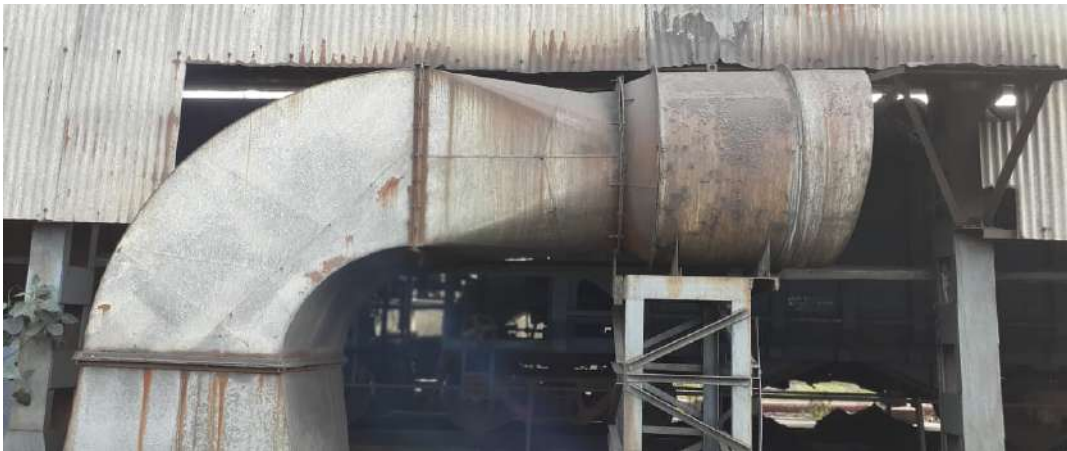
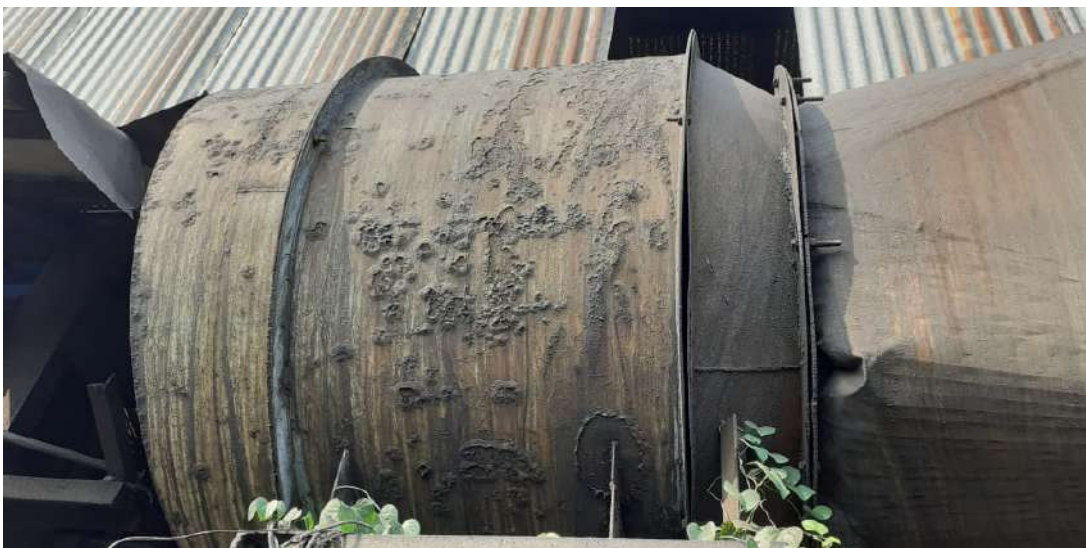
4.6 Ventilation System of Track Hopper of CHPB of Unit 5,6&7

On preliminary inspection the existing ventilation system at Track hopper tunnel is not sufficient to supply the fresh air as per MPCB norms. Ventilation system is badly damaged and it is beyond repairable.

In order to ensure the sufficient air in each elevation, provision of new ventilation system is recommended by renovation of existing ventilation system as per requirement. Further Environmental Pollution Control norms have been made more stringent and are observed very strictly which enforces to take all necessary renovation upgradation which control fugitive emission within prescribed limits of MPCB. Hence, it is very much essential to install New Ventilation system to avoid human health hazard.

To achieve healthy working environment condition and also to maintain the ambient air temperature & sufficient fresh air at Track Hopper Tunnel in all the season, it is recommended for Work of Modification/Renovation/Upgradation of Ventilation System of Track Hopper of CHPB of Unit 5,6&7 of CSTPS Chandrapur

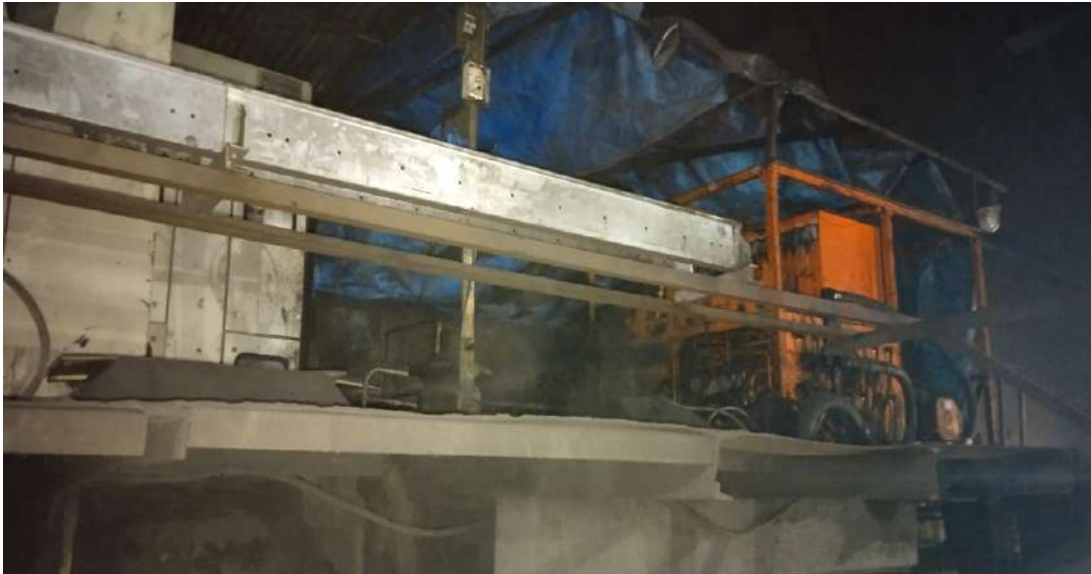
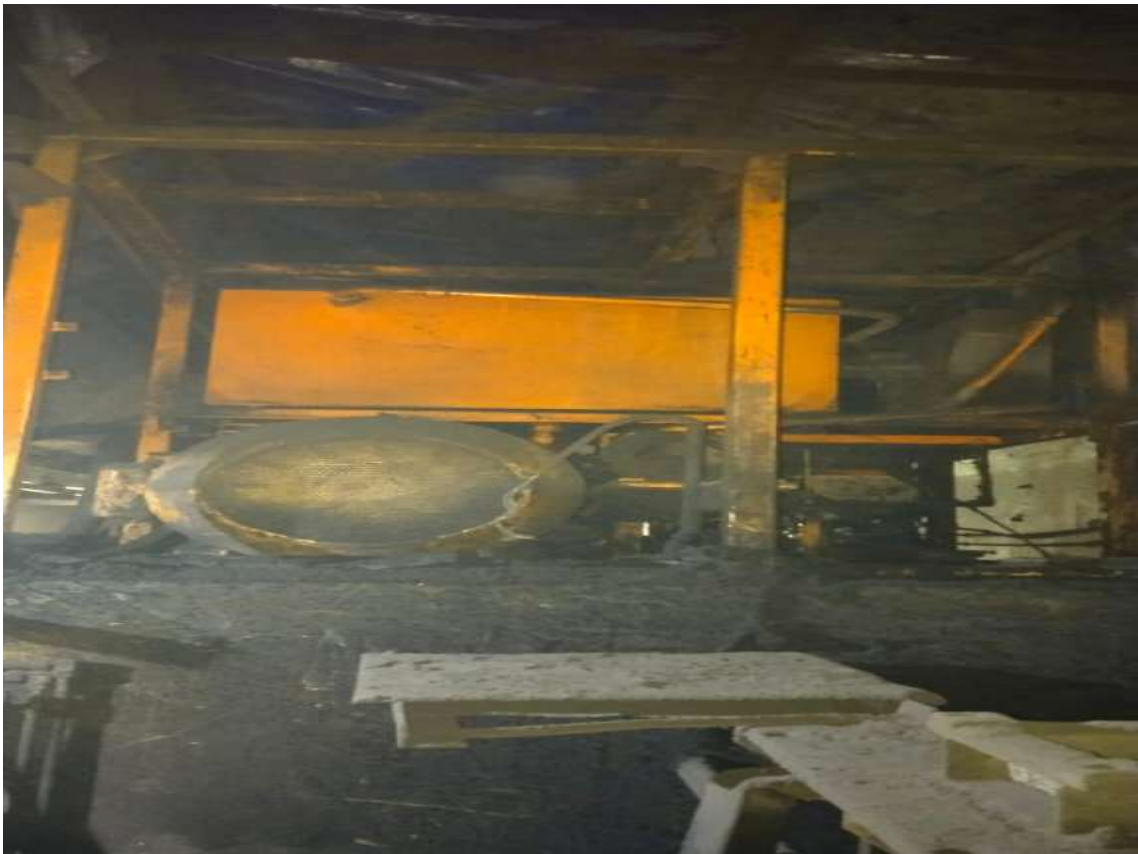
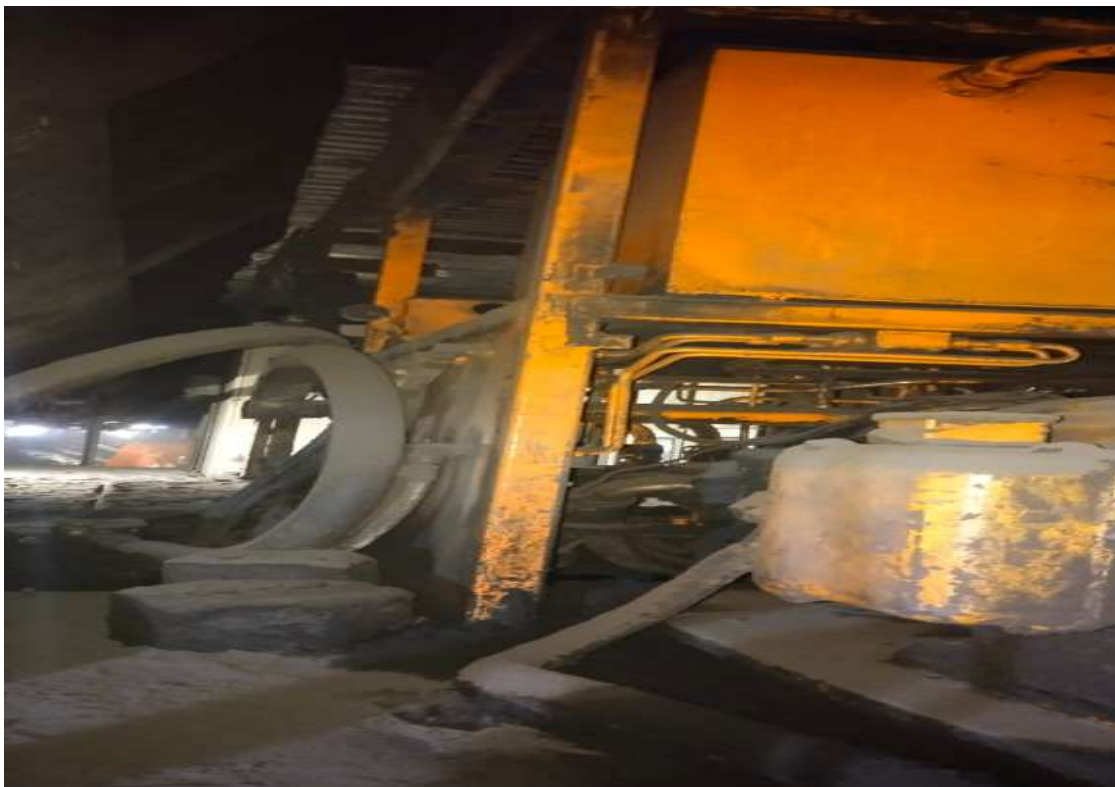
4.7 Work of Renovation /Upgradation of Hydraulic System of Paddle Feeder at CHPB of Unit 5,6&7

Smooth running of Paddle Feeder plays very vital role in unloading of BOBR wagons within a given time and also play important role in bunkering. Failure of this system may hamper complete unloading result in poor unloading and penalizing of demurrage charges. Paddle Feeder is at CHPB in the year 1992 and hydraulic system of Paddle Feeder is design & supply in 1989-90. Hence maximum availability of this system healthiness of this equipment's is very essential. Since the Paddle Feeder is in service since last 35 years the mechanical maintenance of this paddle feeder and aging effect as per the history records. OEM has declared that existing hydraulic pumps, valves are obsolete and suggested to change the hydraulic system for up gradation so that it will work for next 15-20 years and the required hydraulic spares may be easily available in the market. Control panel of existing paddle feeder is of old version and the Electronic Amplifier Card obsolete & is not available in market. Hence it was repaired by local party to cater to the present need but the service life is of short duration and frequent repairing is needed which eventually hamper the Paddle Feeder operation. All interlocks are also not in service which is of great concern as far as safety point of view.

In view of the above it is recommended to renovate the three nos. of Paddle Feeder by replacing hydraulic system with upgraded version so that after renovation it may work for next 15-20 years with assurance of availability of spares.

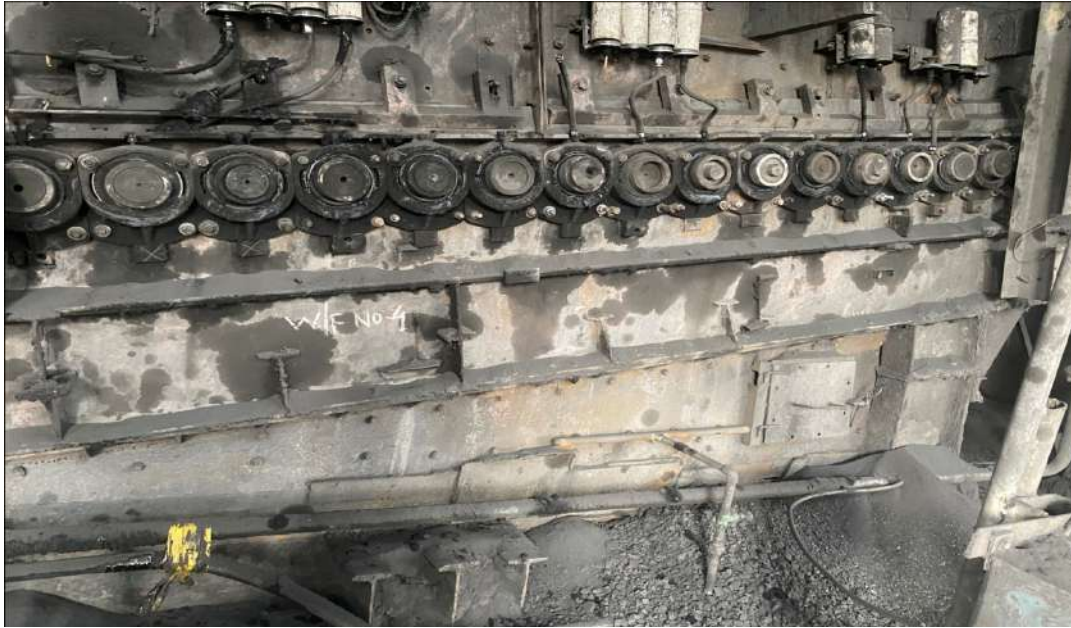
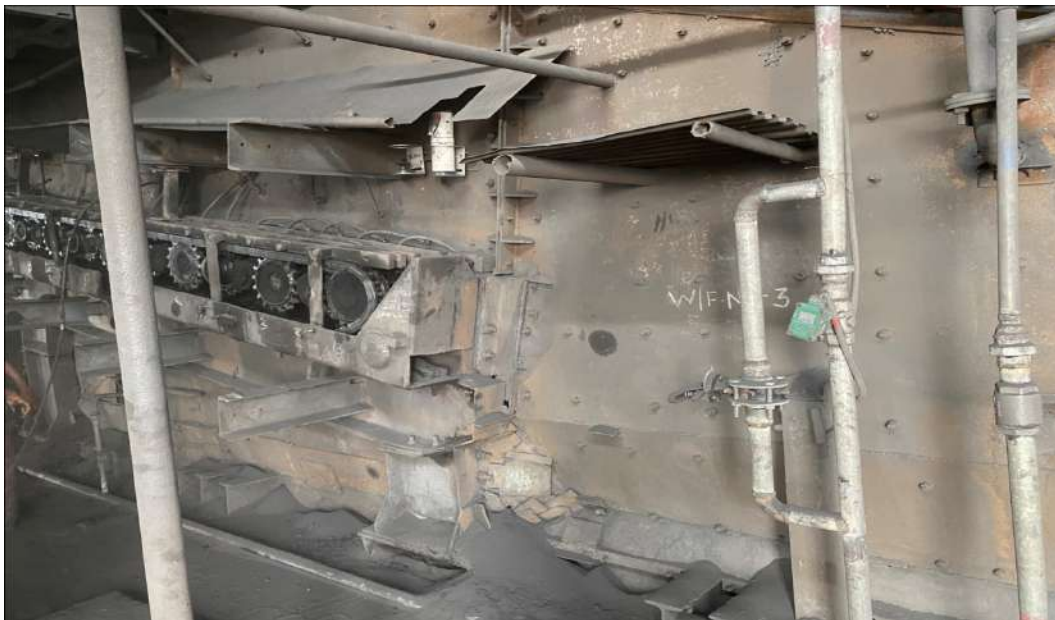
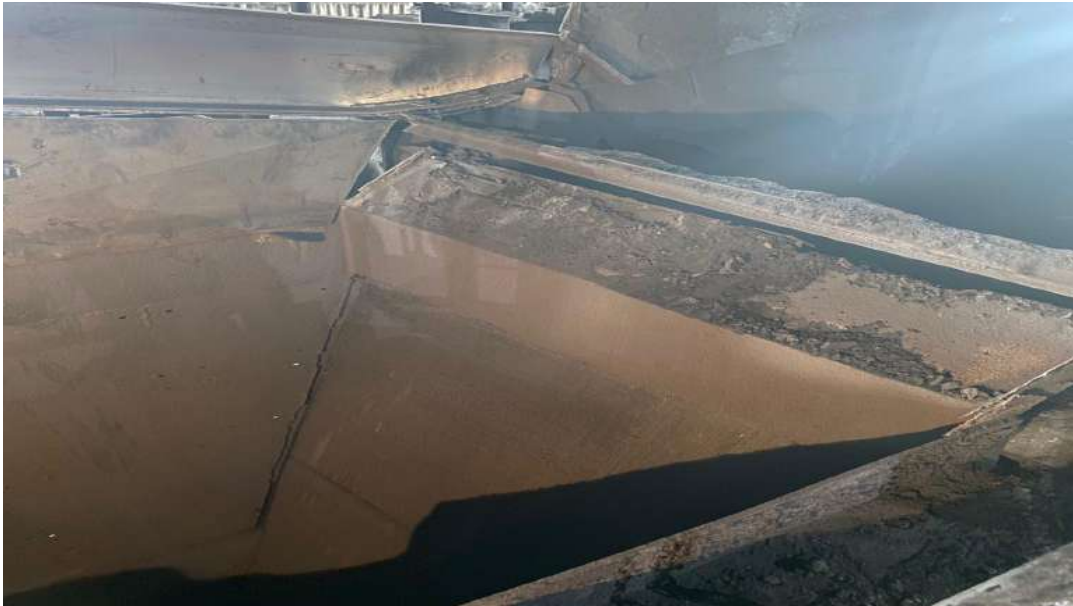
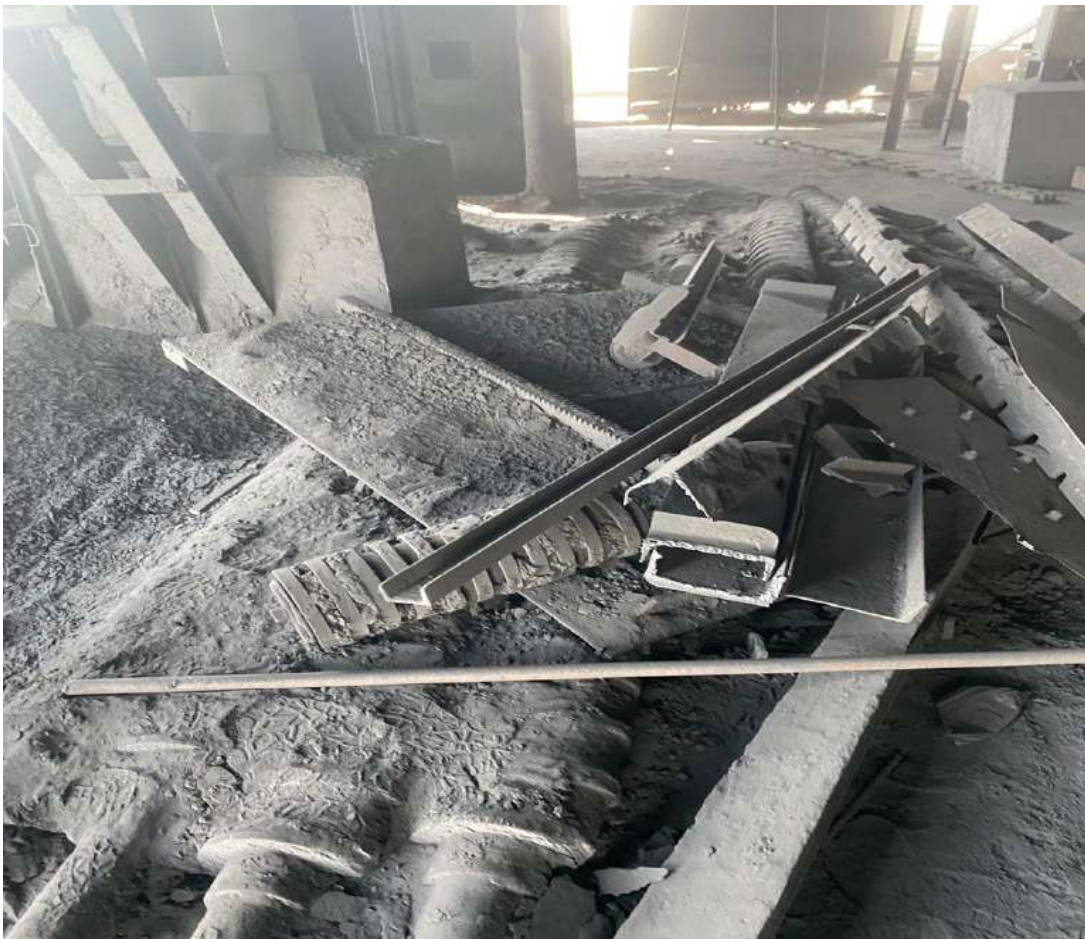
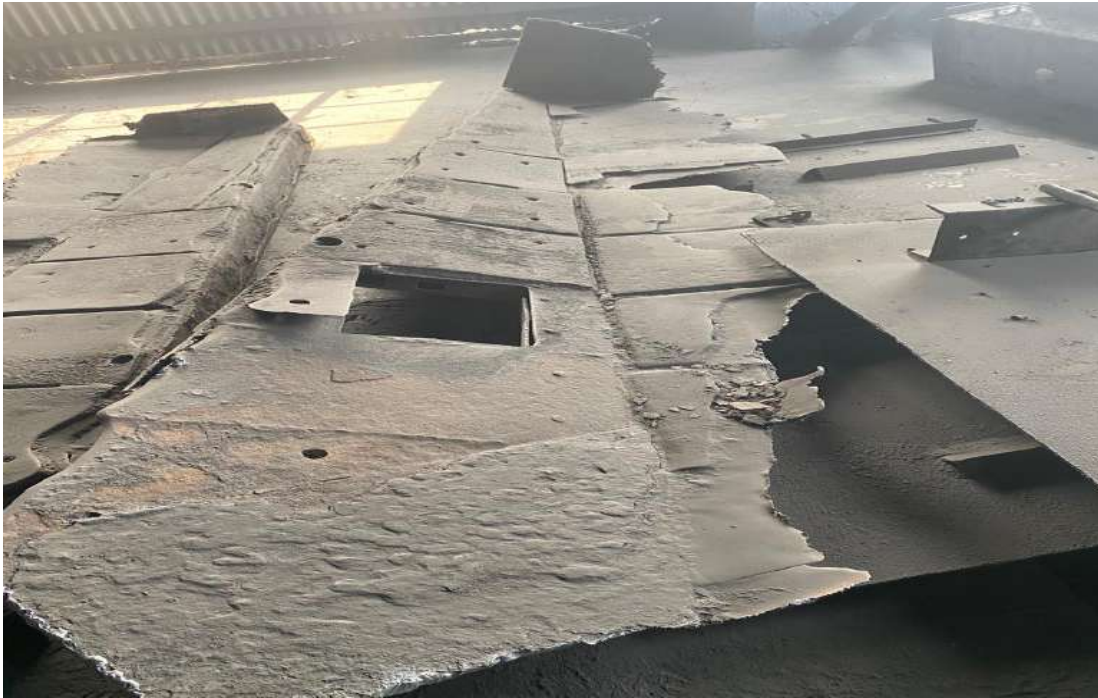
4.8 Design, Engineering, Manufacturing, Fabrication, Erection and commissioning of Modified Wobbler Feeder at CHPB of Unit 5,6&7

Four nos. Wobbler Feeders are installed & commissioned in the year 1992 for raw coal at a controlled rate and scalping fines from theraw coal received from various coal mines and in service since commissioning. Due to continuous operation of wobbler feeders since commissioning, most of the spares viz wobblers feeder head & tail bar , wobblers bar – intermediate, wobblers bar –intermediate, triplex roller chain 2" pitch x 177 links + 1 master link triplex roller chain 2" pitch x 177 links + 1 master link, simplex cahin simplex cahin, hold down bar hold down bar, drive chain sprocket, UCX-20 Bearing & Housing UCX-20 Bearing & Housing of Wobblers Feeders are worn out results into misalignment and subsequently disturbance of timing of Wobbler bars results into outage of Wobbler Feeders. Also receiving & discharge chutes of Wobbler Feeder is

also damaged badly. Patches welded at various places in the past. The main girder of wobble feeder on which wobbler bars are positioned through UCX20 bearing & housing is also rusted & worn out which resulting frequent looseness in bearing housing bolts. Consequently the non-availability of Wobbler Feeder and its consequential effects on unloading and transporting of coal, may causes to levy more demurrage charges, also a generation loss due to poor bunkering. Hence maximum availability of this system and healthiness of this equipment's is very essential.

In view of above and for better performance of Wobbler Feeders of Coal handling plant B in terms to reduce unavailability of unloading stream and to reduce demurrage charges, it is recommended to replace the 03 nos wobbler Feeder with modified wobbler Feeder of CHPB of Unit 5,6&7 in CSTPS Chandrapur.
