**INSPECTION OF DAMAGED /RUNNING/FAILED PARTS
CHPA/B/C of Unit 3 to7**

**M/s. CHANDRAPUR SUPER THERMAL POWER
STATION,MSPGCL,CHANDRAPUR**

***CENTRAL POWER RESEARCH INSTITUTE
THERMAL RESEARCH CENTRE,DHUTI– 441108,
DIST.-NAGPUR (M.S.)***

TEST REPORT NO. & DATE	: TRC/EMD/TOS-290/2022-23/FR Date 18.03.2023
CLIENT'S ADDRESS	: Chief Engineer, Chandrapur Super Thermal Power Station, Maharashtra State Power Generation Co. Ltd., Chandrapur. (M.S.)
WORK ORDER NO.	: email dtd. 03.03.2023
PARTICULARS OF COMPONENT INSPECTED	: Components CHPA/B/C of Unit 3 to7
PERIOD OF INSPECTION	: 16.03.2023-18.03.2023
PARTICULARS OF INSPECTION	: Inspection of damaged /running/failed parts at CHPA/B/C of Unit 3 to7
TEST IN ACCORDANCE WITH STANDARD/SPECIFICATION/ CLIENTS REQUIREMENT	: As per client's requirement.
DEVIATION IF ANY	: NIL
NUMBER OF PAGE	: 53 Pages.(Fifty Three pages only)

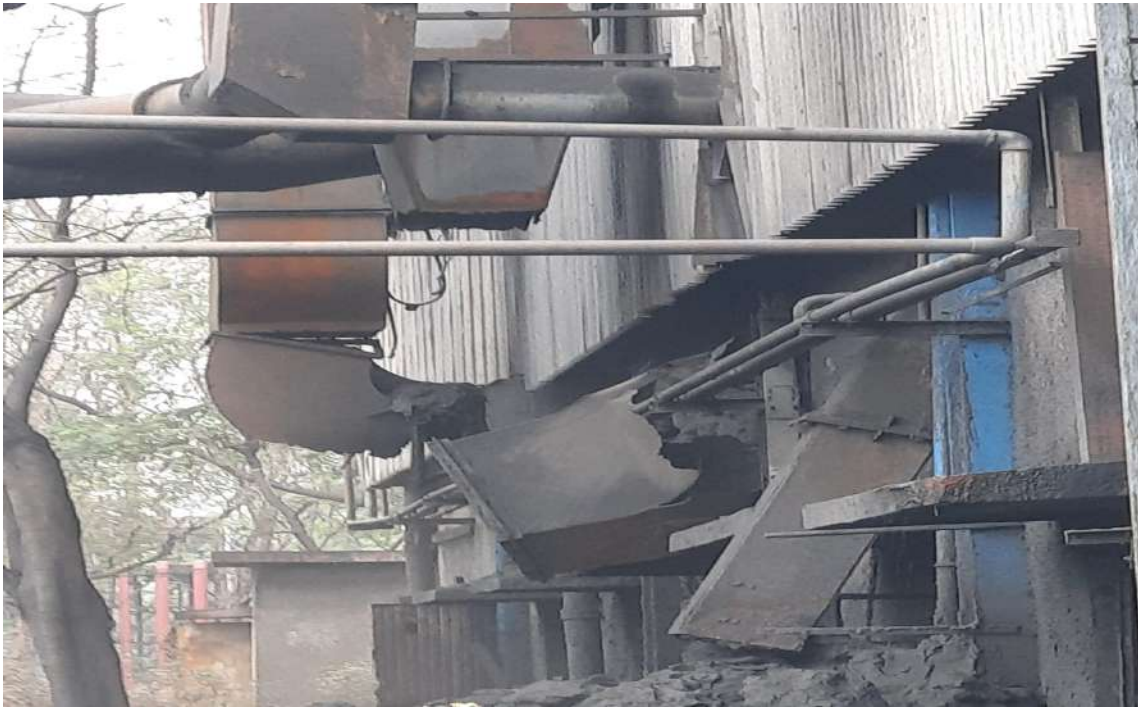
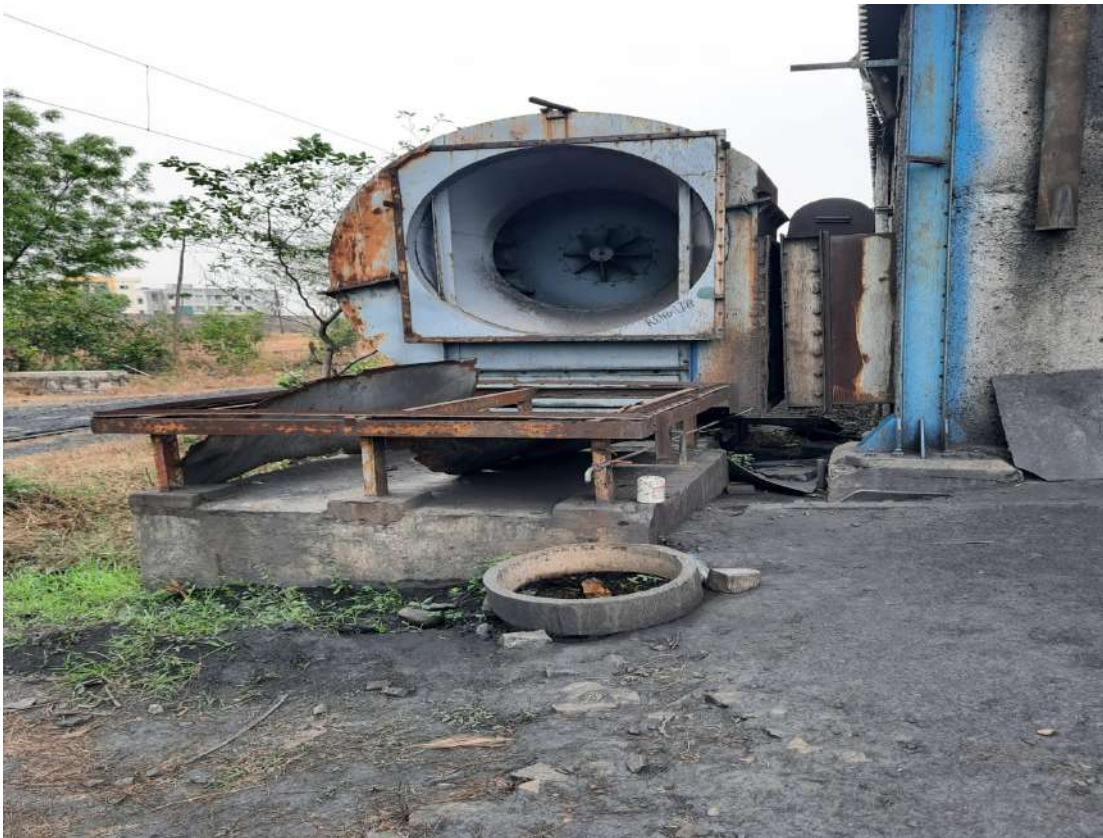
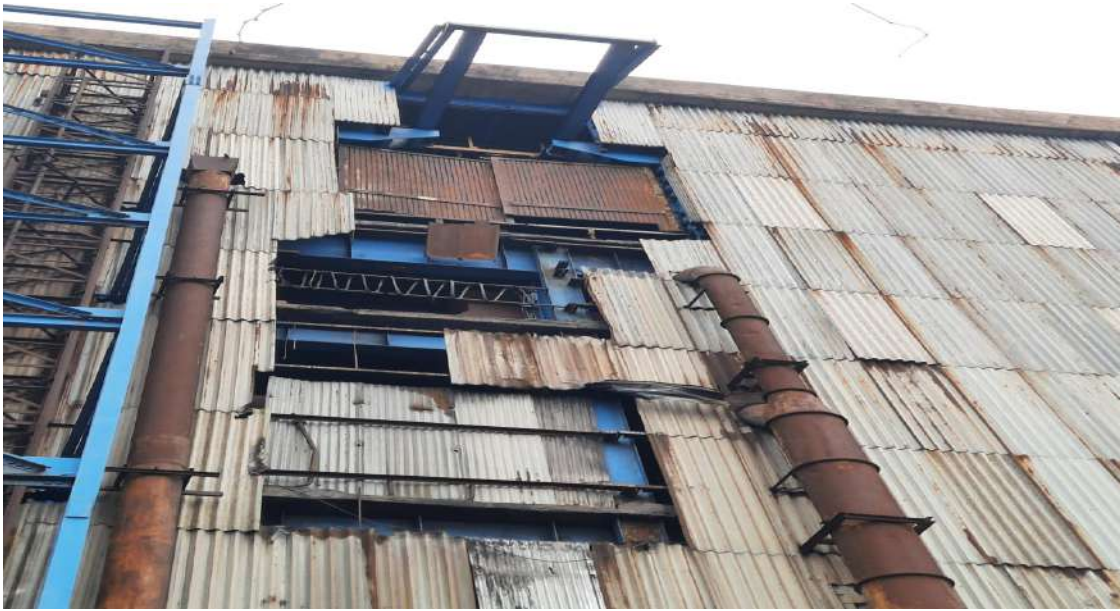
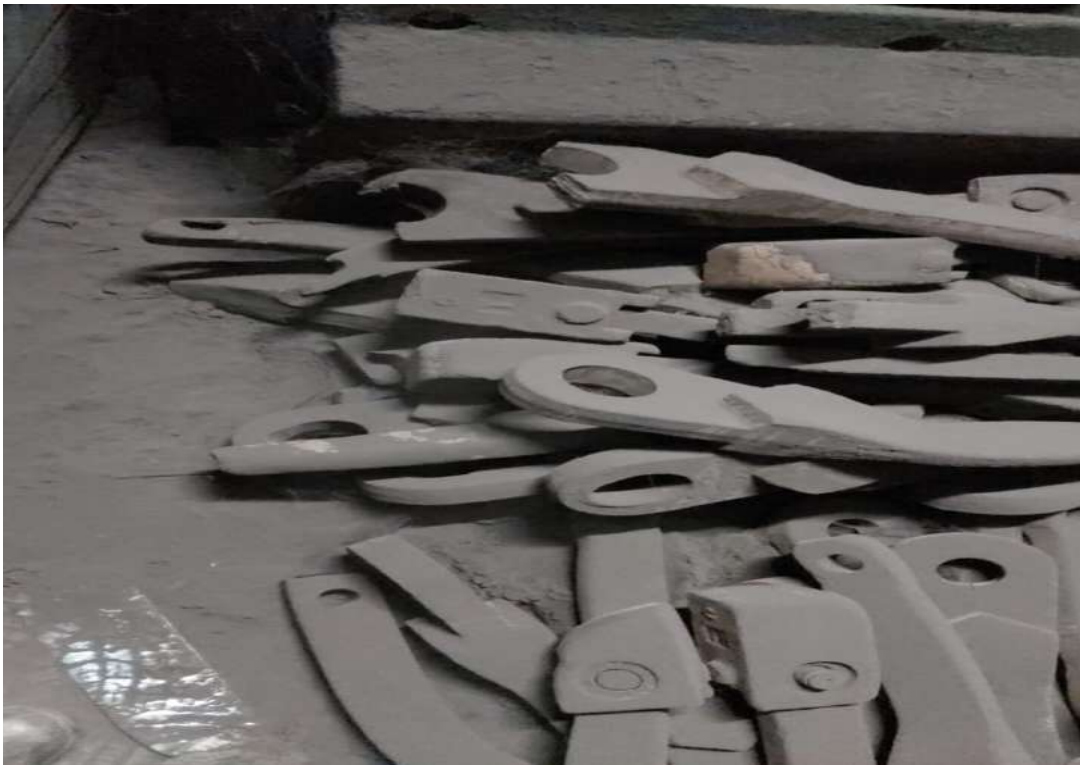
4.9 Crusher House & Track Hopper Unloading System of CHPC of Unit-6&7.

Installed crushers & wobbler feeders of CHPC are in service commissioning (i.e., 1997) and failures/breakdown of crushing elements or screening elements are increased due to long service life. As per history register many times repeated work carried out to attend the breakdown and put in service, but getting very less service life. Hence it is very much essential to upgrade/renovate the existing elements of crusher & wobblers to give sustainable life and able to handle coal more than 9000 MT coal per day.

To avoid ingress of dust from crusher house during crushing & transportation of coal, crusher house structure is covered with corrugated GI sheet. Healthiness and availability of sufficient corrugated GI sheet is essential to ensure proper enclosure of Crusher House and it is statutory requirement for dust emission control. During inspection most of the corrugated GI sheet are damaged which needs to replace with new upgraded size and type of sheet for longer service life with proper enclosure of crusher house. Also it is observed that CHPC Crusher House is very

nearer to public school and due to noise produce by crusher house it creates noise pollution and affects them. Further it is observed that mechanical lift provided is condemned.

Considering long service life with other aging effect and Critical Auxiliary as comes under generation path it is very much essential to taken up the work of Work of

Upgradation/Renovation of Crusher House & Track Hopper Unloading System of CHPC for smooth running of coal handling plant that includes smooth unloading of wagons, smooth bunkering & safety and other statutory norms so that all auxiliary in Crusher House will run sustainable capacity for next 15-20 years and to run the all the Units of 500MW as per KRA target. For abatement of noise, it is recommended to suitable sound barrier along the length of public school. For mechanical lift it is recommended to remove it for safety of human being.

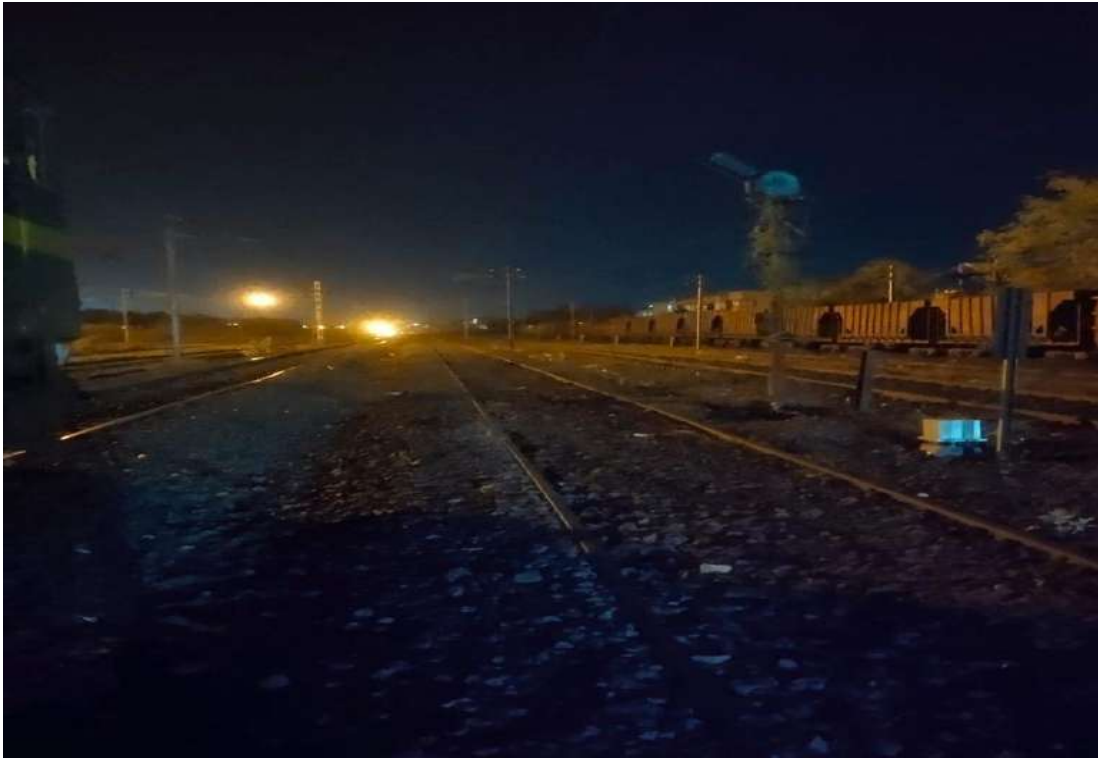
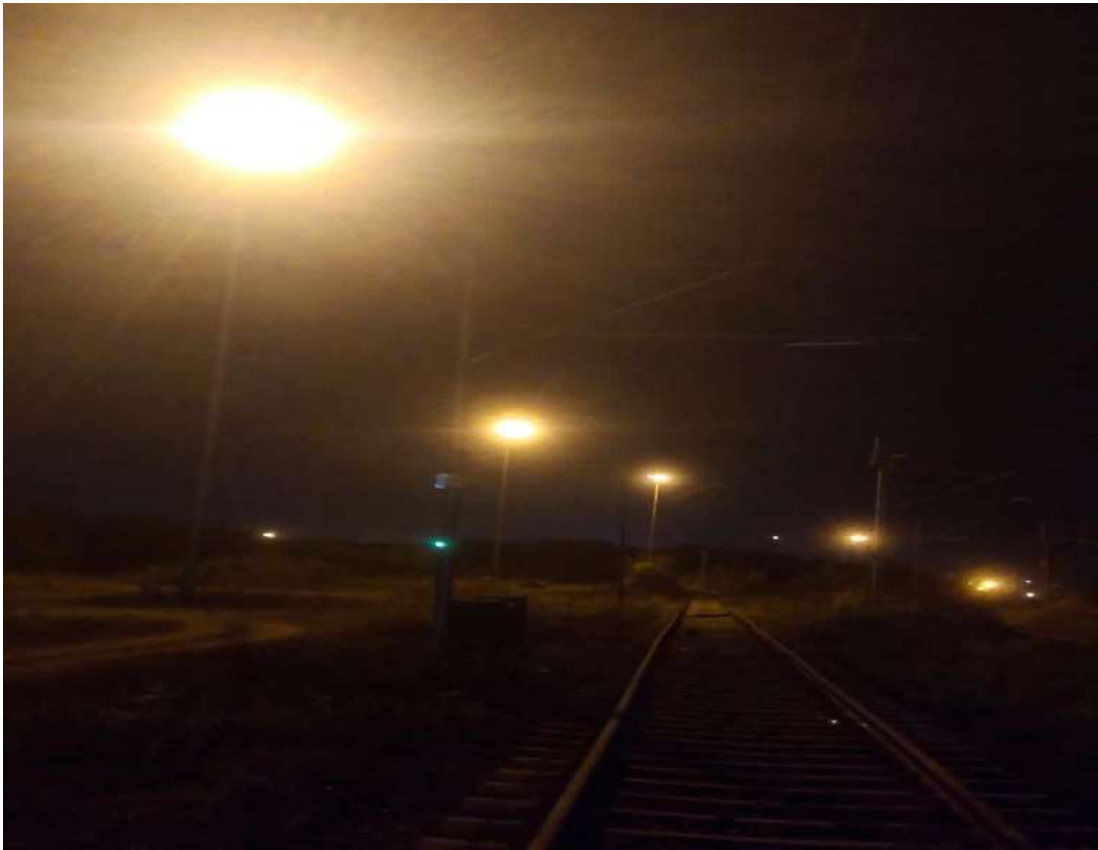
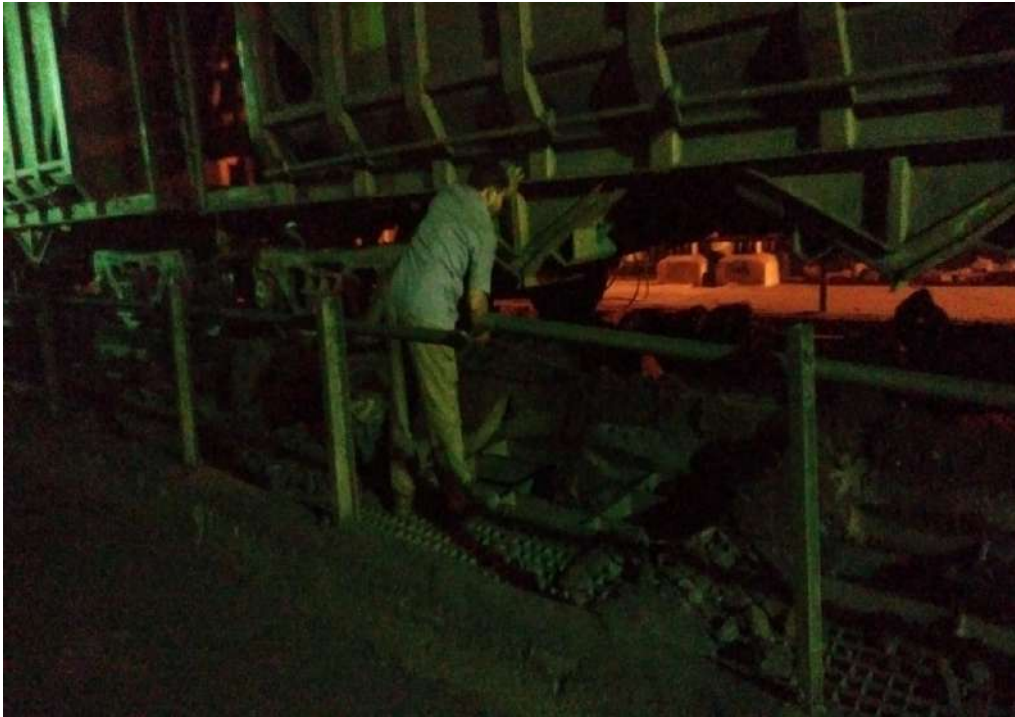
4.10 LED based energy efficient illumination system at CHPA,B&C.

Conventional lighting systems installed at various locations of CHP- A, B & C consist of high intensity discharge (HID) lamps such as metal halide or high-pressure sodium lamps. In conventional lamps like incandescent and gas discharge lamps, most of the electricity is wasted in terms of heat and also since ballast requires high voltage at the time of starting, these consume more power, making them extremely energy inefficient. These conventional lighting systems are installed since commissioning of respective coal handling plants, and in due course of time, many fixtures, wiring, junction boxes, conduits etc. are damaged and corroded because of excessive coal dust prevalent in CHP area. Therefore, frequent occurrences of short circuits and flashovers in old lighting circuits are common and are hazardous to safety of operation and maintenance personnel thereby affecting the quality of lighting system. Conventional lighting consumes far more energy producing a lot of heat as well, and the hot equipment can be difficult to handle and manage. Also due to significantly shorter life, conventional fixtures have to be replaced and repurchased often. This directly increases the cost of maintaining the lighting system with increased inventory requirement and manpower management. Also due to various onsite modifications and addition of auxiliaries over the years, the existing lighting system has become insufficient to maintain the required illumination level. There has been an unbalanced phase distribution of lighting circuits is also one of the major issues of concern. The lighting design also strongly affects visual performance and visual comfort by aiming to maintain adequate and appropriate illumination while controlling reflection and glare.

By installing advanced lighting technologies, reduction in the amount of electricity consumed and energy costs associated with lighting can be achieved. Energy efficient lighting reduces the electricity demand and is a cost-effective method of lighting system compared to conventional lighting methods. Energy efficient lighting includes the use of more illumination from less power lights by replacing high power consumption lights like incandescent, high discharge lamps, etc. It will also replace high power lighting accessories by low power devices such as electronic ballasts, fixtures, etc.

In view of above, it is recommended for Design, supply, installation & commissioning of LED based energy efficient illumination system at CHP-A, B & C.

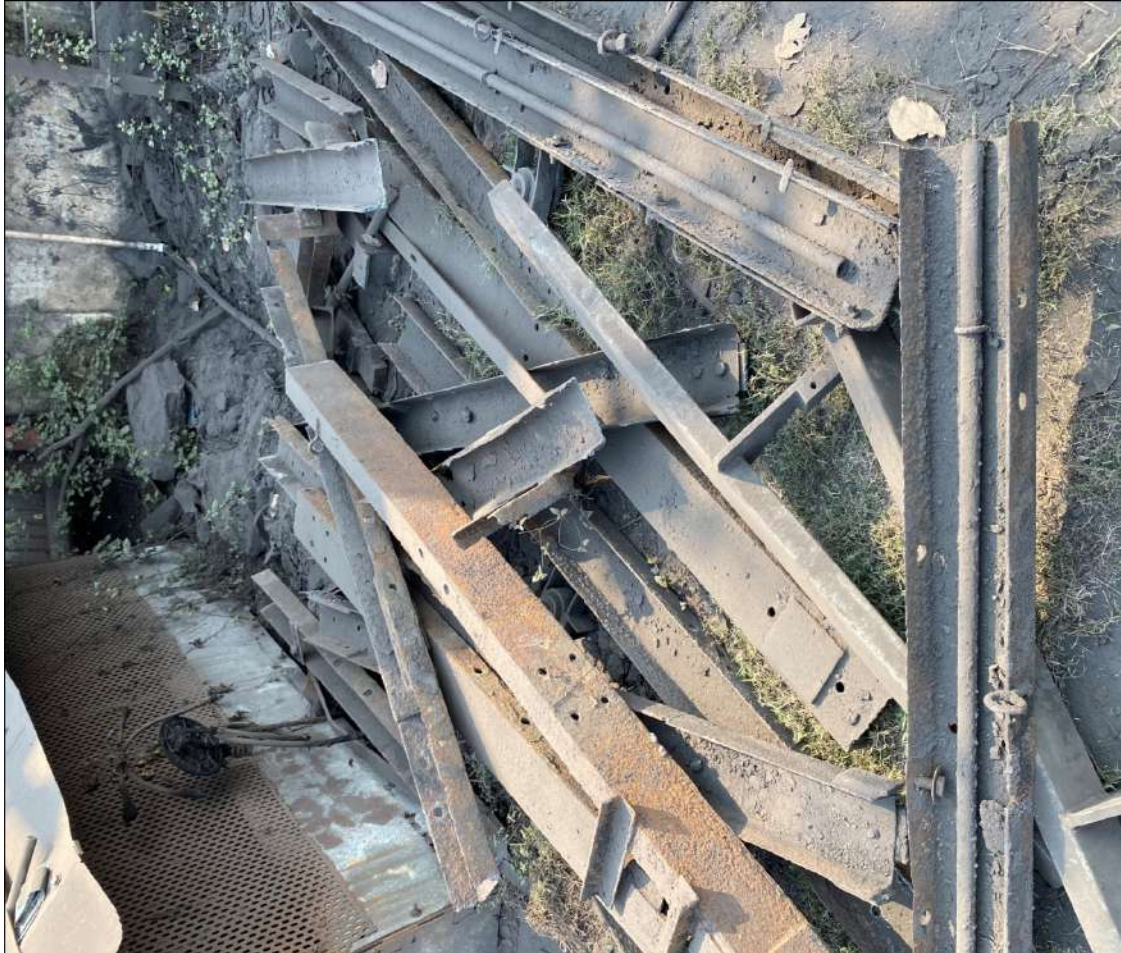
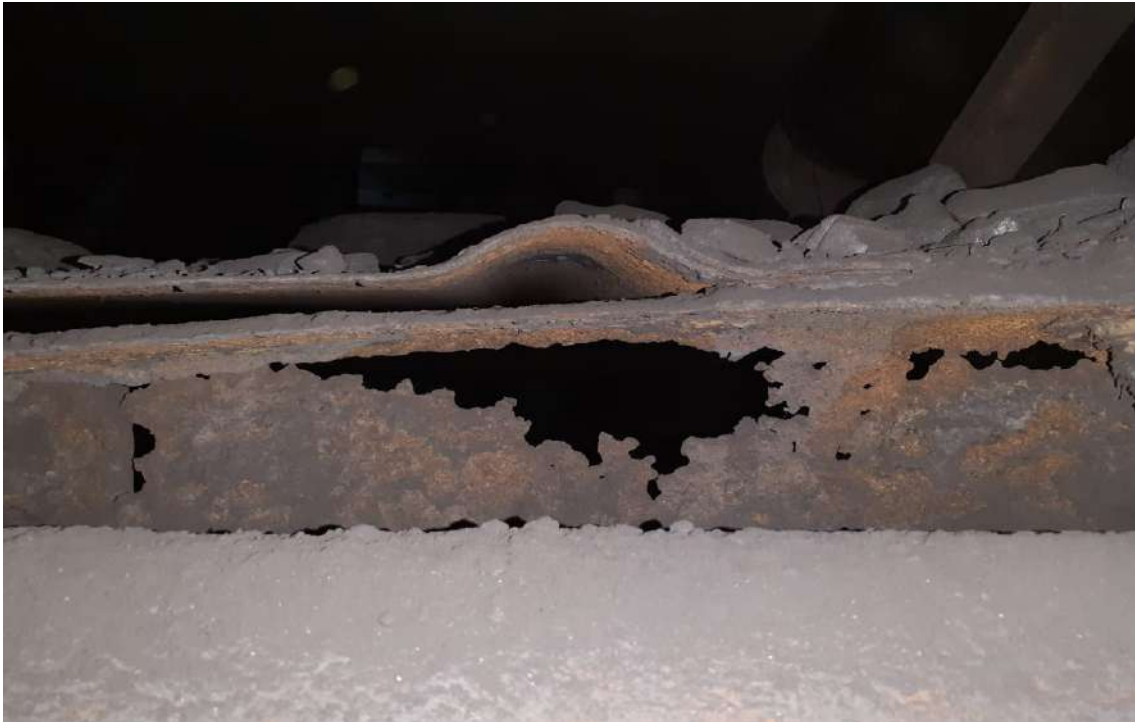
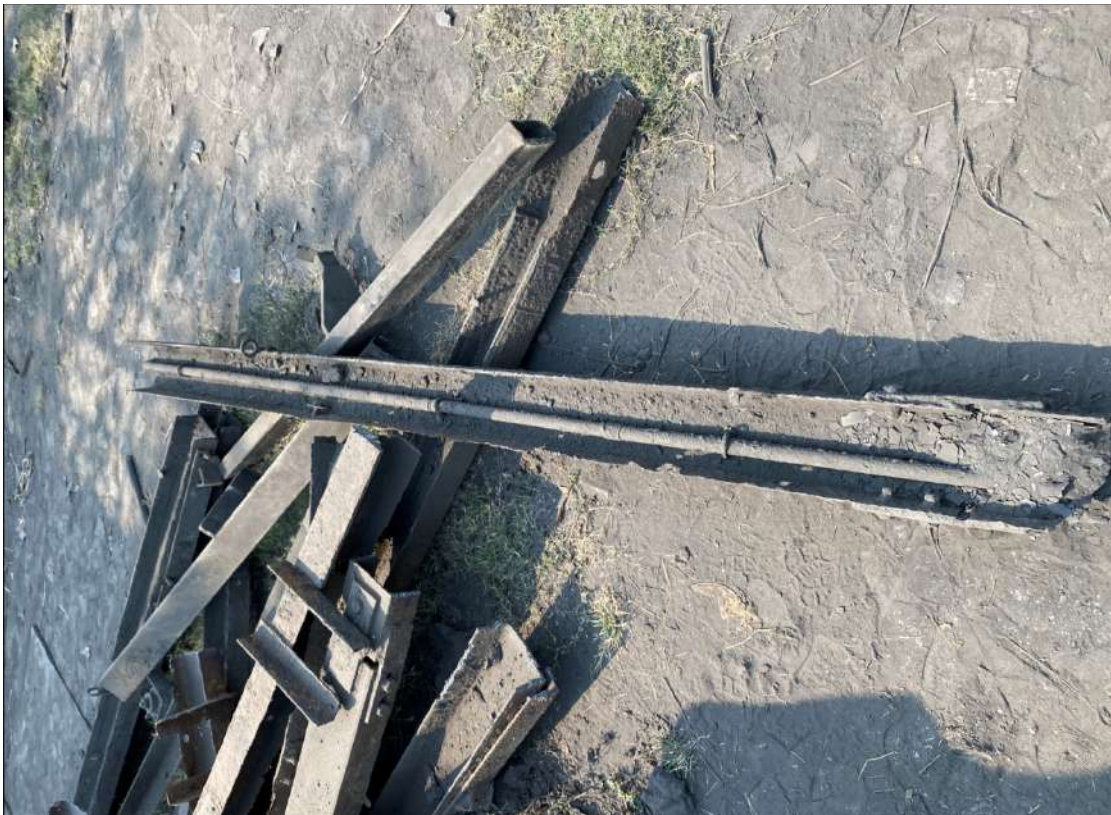
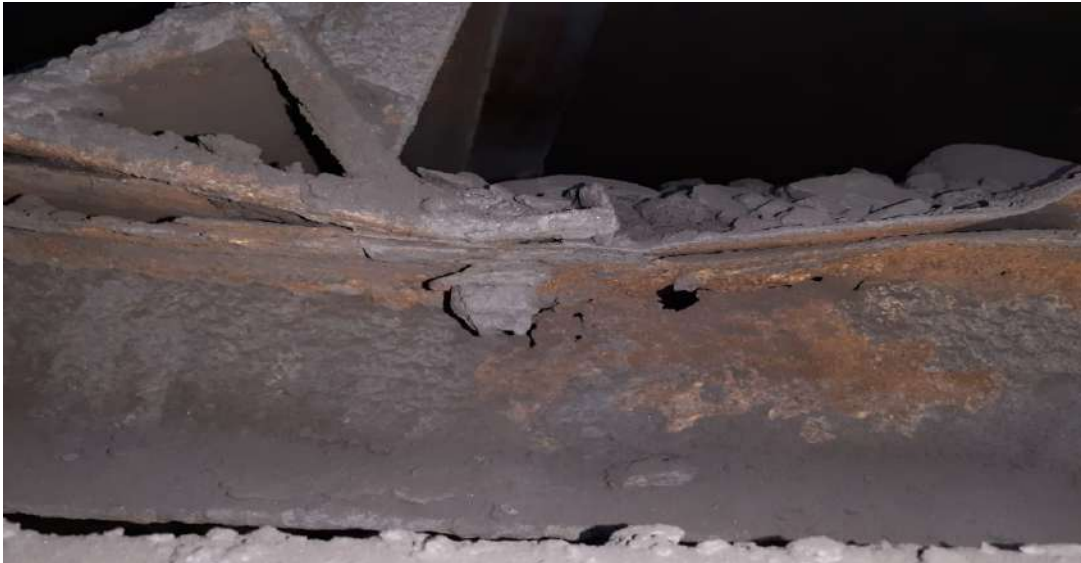
4.11 Conveyor deck module for underground belt conveyor streams of CHPB of Unit 5 to 7

Belt Conveyor 102A/B/C and BC 105A/B are partial underground conveyor belt of CHPB and play very key role in unloading of coal and bunkering of coal. On thorough inspection of the deck module of underground conveyor installed in CHPB, it is found that the deck channels and supports are badly corroded. The vertical supports are damaged or dislocated at many places. This

led to the misalignment of the deck channel structure which further led to the running out problem of conveyor belts. Due to spillage of coal & corrosive property of coal, most of the deck plates are badly rusted, dislocated and tend to touch the conveyor belt on return side. In past strengthening or repairing of these damaged stinger channel /angle post has been done.

The rusted deck module needs immediate complete replacement with providing proper angle support underneath and painting with anticorrosive paint. In past strengthening or repairing of these damaged stinger channel /angle post has been done, but now it is beyond repairable and its angle post dislocated from concrete foundation.

Hence it is very much essential and recommended to taken up the work of Renovation & upgradation of conveyor deck module for underground belt conveyor streams of CHPB by replacement of conveyor deck module with allied works on urgent basis in CHPB.

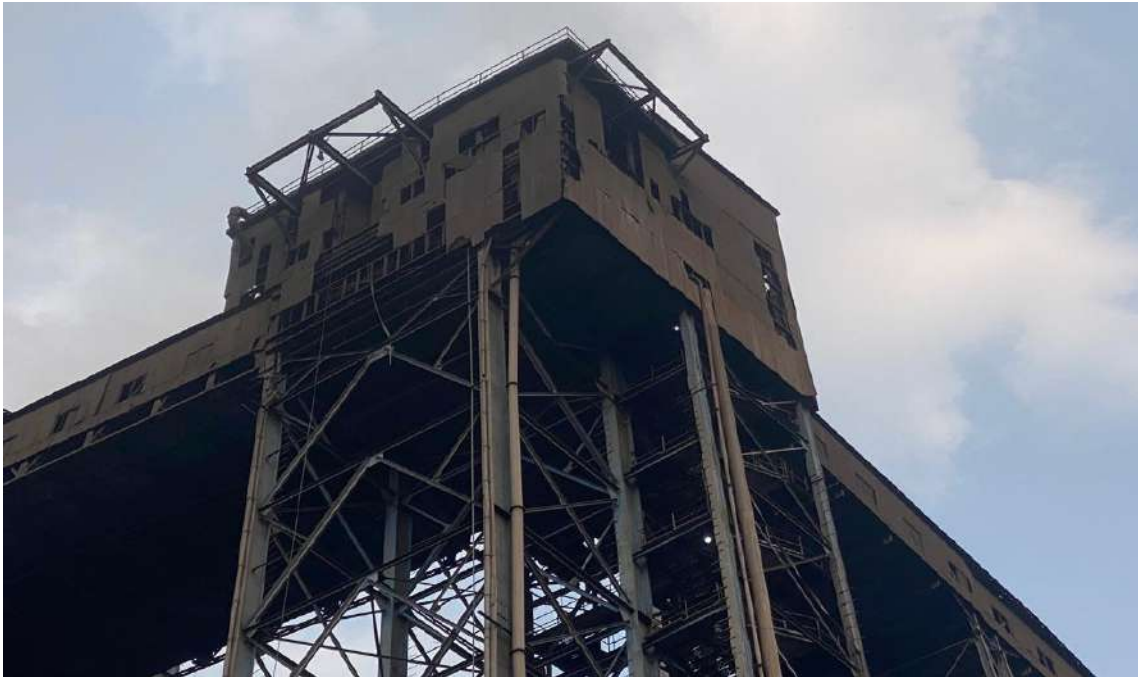
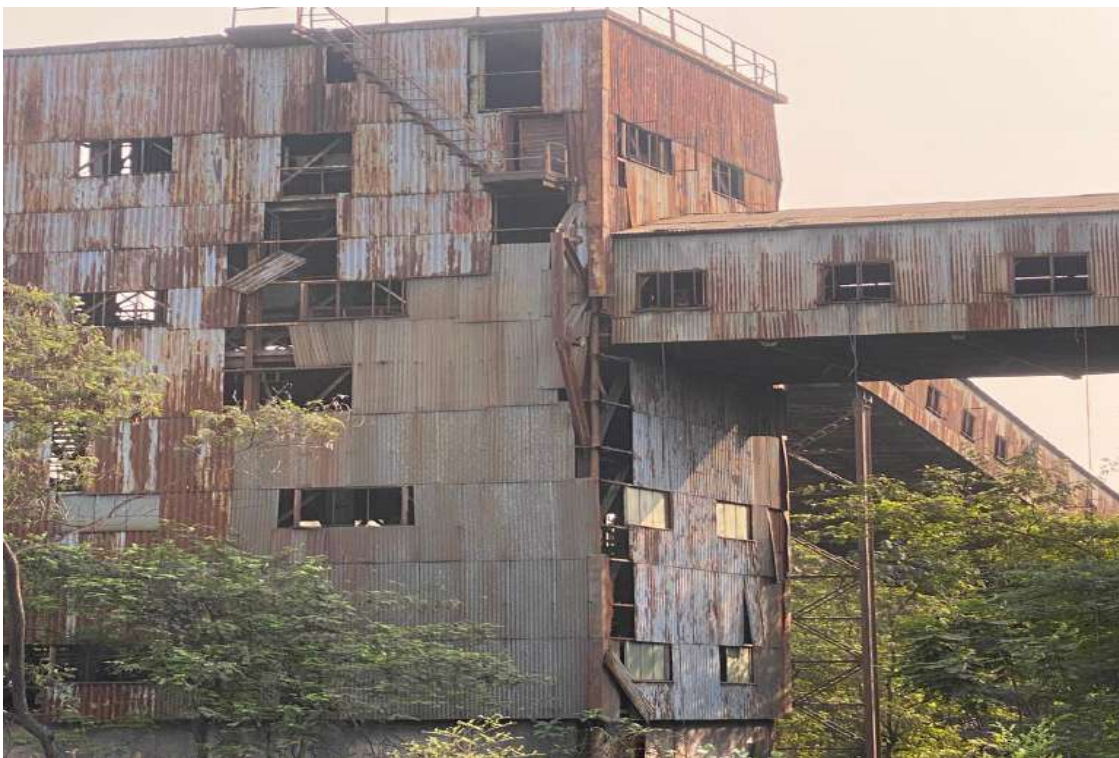
4.12 Transfer Point of CHPB of Unit 5 to 7

Various Transfer Points (like TP104/TP105/TP106/TP 110/11) are installed at CHPB to transfer the coal from one conveyor to another conveyor by longitudinal or transverse transfer. Healthiness, reliability and safe working operation activities at Transfer Points is very much essential for smooth transportation of coal from unloading end to bunkers of all units. These transfer points are in service since commissioning. Due to rusting & abrasion property of coal, transfer points structure has leads to heavy vibration. As per history register in past such type of vibrations are noticed and attended locally at Transfer Point 104.

The dust emission is occurred in Transfer Point during transportation of coal. Transfer Pont structure is covered with corrugated GI sheet to avoid dust ingress in atmosphere. Healthiness and availability of sufficient corrugated GI sheet is essential to ensure proper enclose of Transfer

Point and it is statutory requirement for dust emission control. In past some damaged corrugated sheets are replaced with new.

Further it is observed that mechanical lift provided at TP 104 is condemned.

To address above, Transfer point vibrations analysis along with structural audit will be required and necessary modification & modernization of Transfer Pontstructure is recommended. The dust emission is occurred in Transfer Point during transportation of coal.Transfer Pontstructure is to be covered with new upgraded size and type of sheet for longer service life with proper enclosure to avoid dust ingress in atmosphere.

In view of the above, the Design, engineering, providing & installation of ventilation system as per area of transfer point for fresh air as per statutory norms is recommended. For mechanical lift it is recommended to remove it for safety of human being.

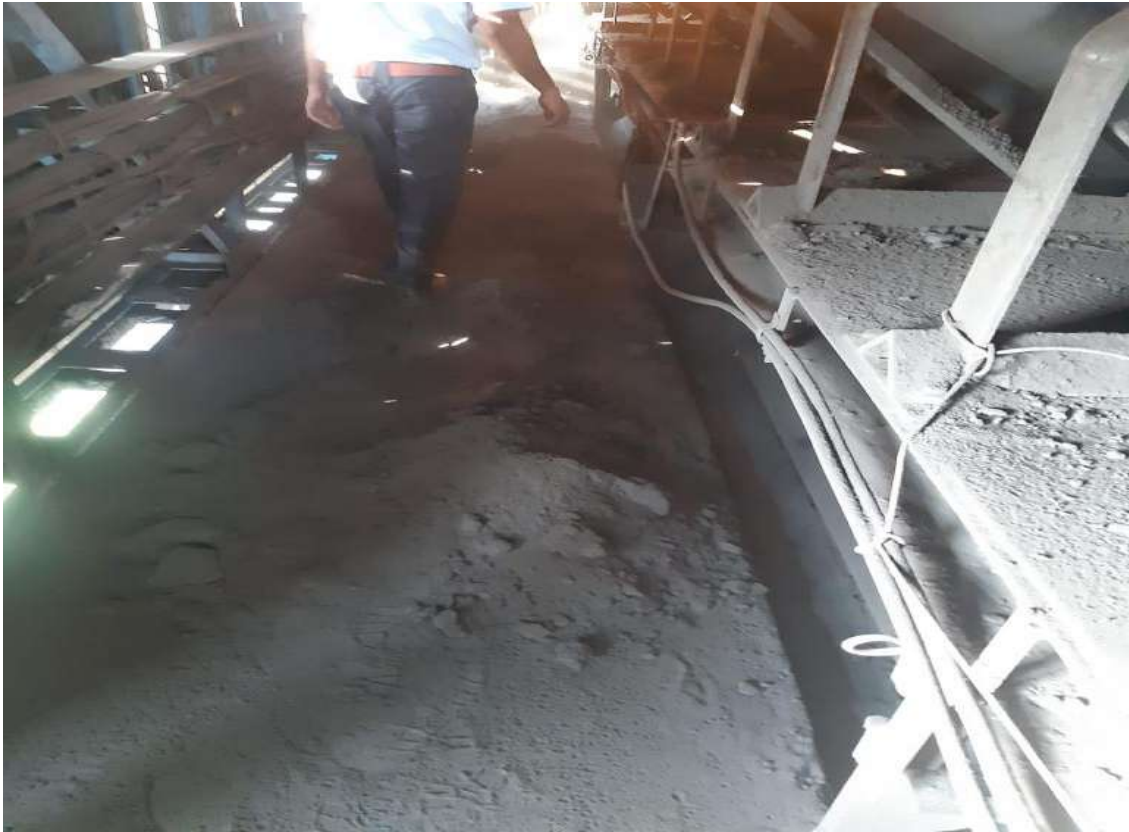
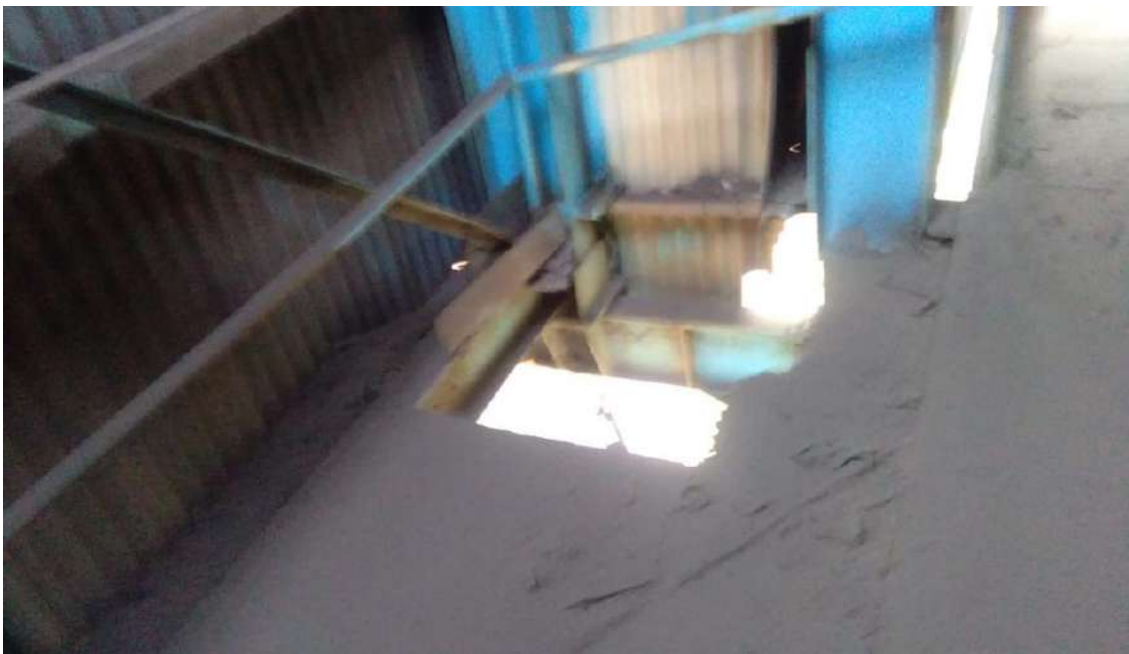
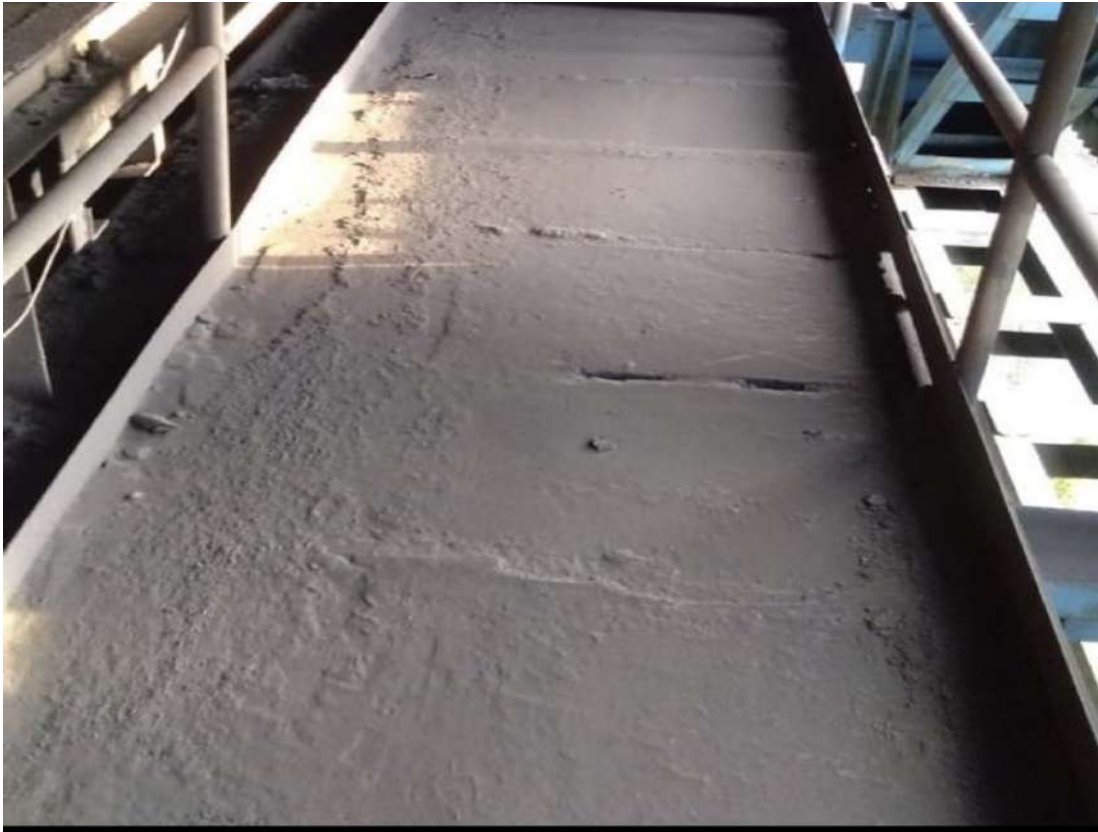
4.13 Walkway pathway of CHPB of Unit 5 to 7

Coal Handling Plant –B of Unit 5,6&7 is commissioned in the year 1992-93 and handling @ 60-70 lakhs MT coal per year. The length of 22 Km conveyor belts is installed in CHPB for transportation of coal from unloading end to bunkers of each unit. To ensure coal at bunkers, smooth running of conveyor belt system is very much essential. Walkway platform are provided on both sides of belt conveyor system for walking, inspection and maintenance of conveyor belt system. The concrete walkway platform is provided at both side of conveyor belt system at elevated height. Healthy and good condition of walkway is necessary for safe and smooth maintenance of conveyor belt system and also safe movement of human being. Due to long service of concrete walkways & accumulation of coal on walkways, dislocating of concrete metals are observed. Hence, in past repairing/replacement/strengthening of damaged walkways platform was done to avoid fatal incidence. However, quantum of concrete walkways is much more, hence till date repeated works carried on walkway way platform for repairing/strengthening, but till date some walkway platforms are not safe. Fatal incidence may happen in CHP due to unsafe condition of walkways platform. At present walkways platform of BC 103A/B, BC 108A/B & BC 109A/B are badly damaged and due to repeated patching/repairing/partial replacement of walkways, it needs modernization of walkways with renovation & upgradation so that it will get sustainable life and ensure healthy working environment.

In view of above, to ensure safety of manpower for healthy working environment, it is recommended for modernization of existing old concrete walkways platform with new upgraded steel platform considering additional features like additional supporting cross bracing, new toe guard, provision of supporting vertical seal plates at receiving ends, main supporting structure replacement, etc.

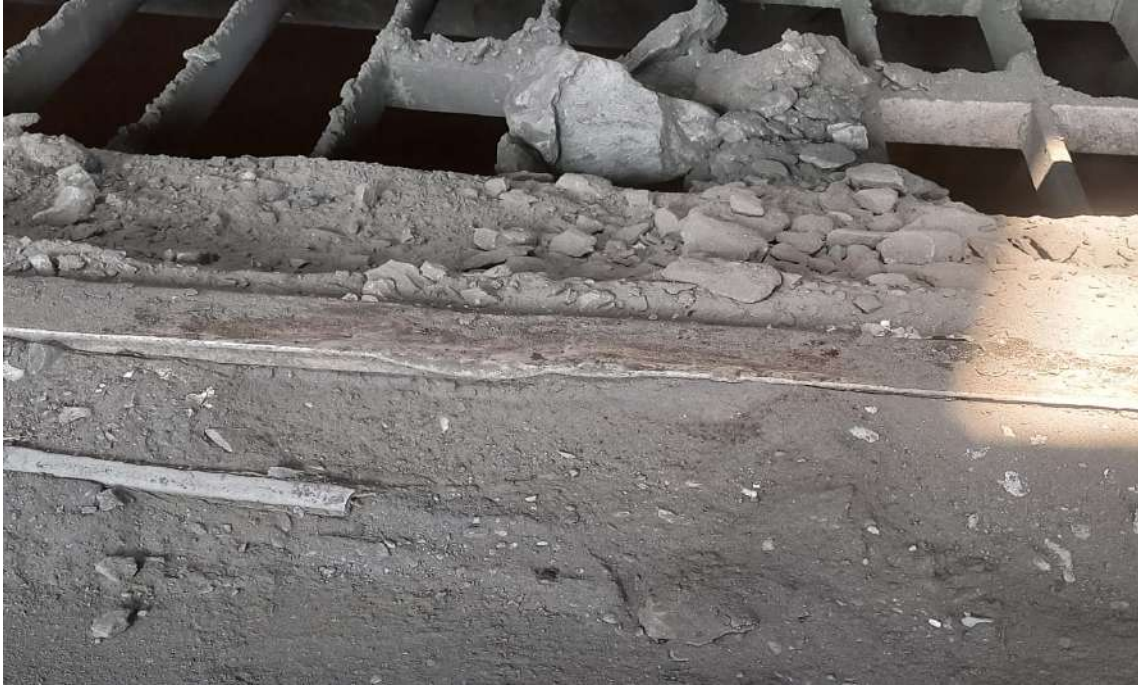
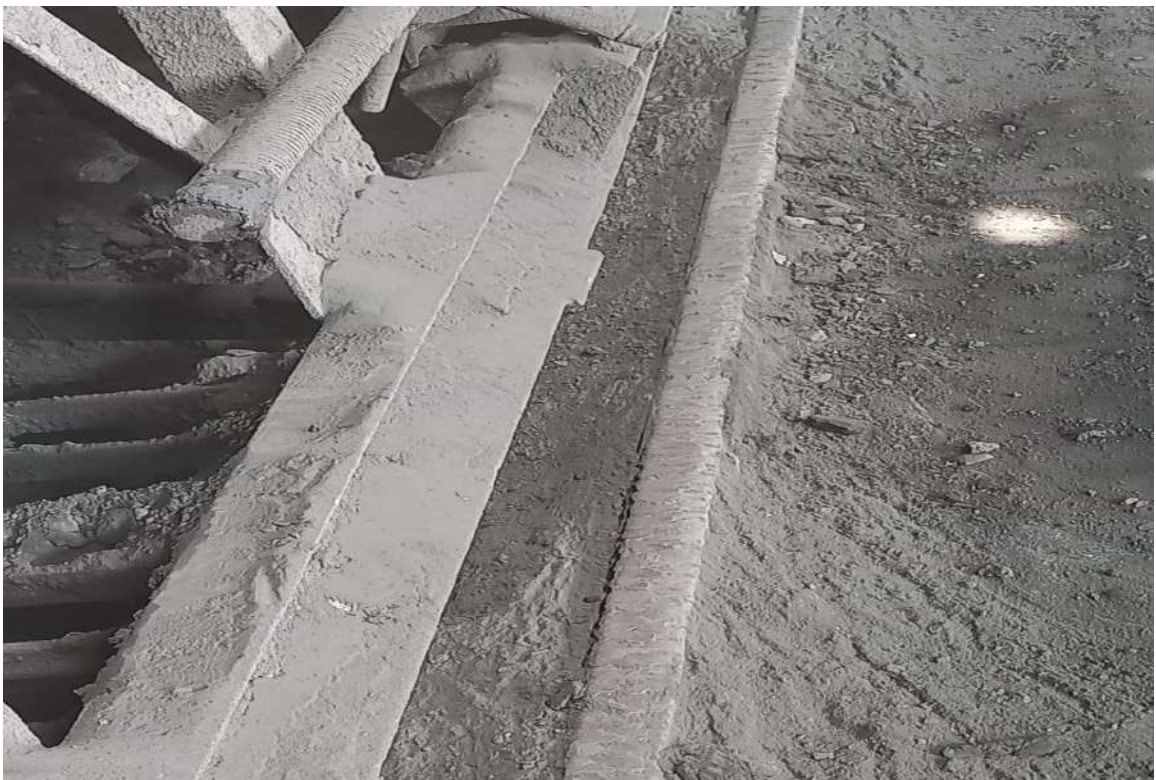
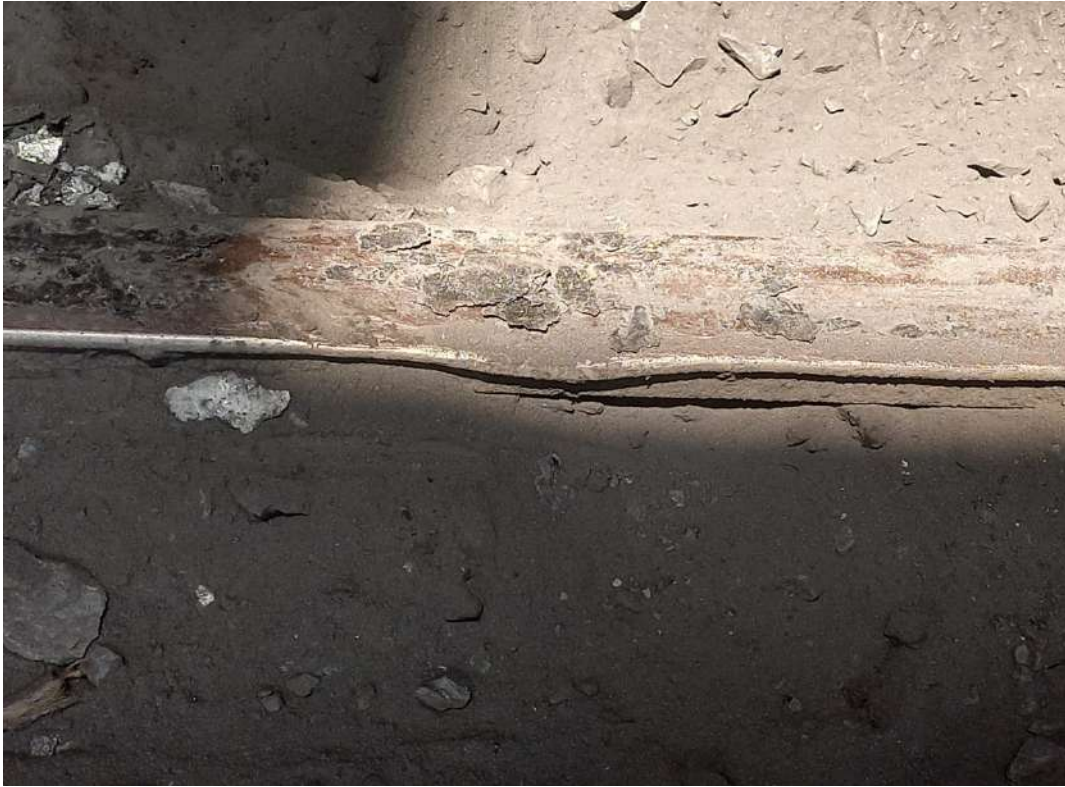
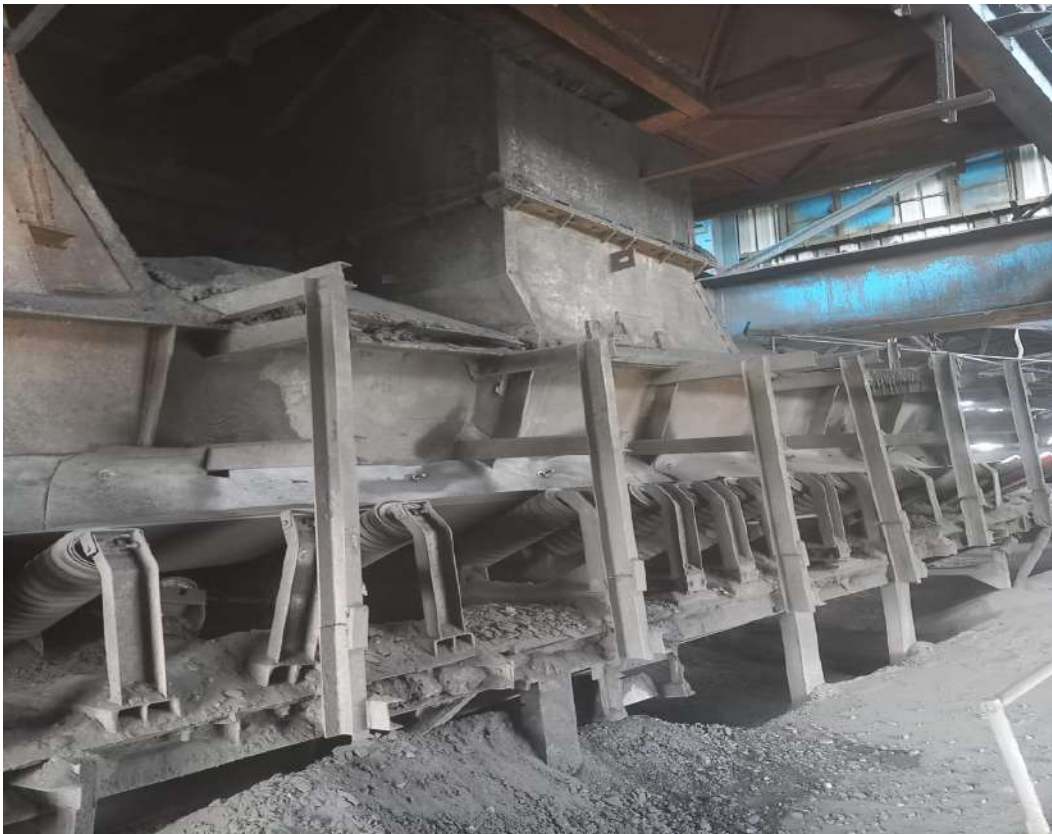
4.14 Bunker Shuttle Conveyor of CHPB of Unit 5 to 7

At CHPB, Belt Conveyor 112A/B, 113A/B and 115A/B are the shuttle conveyor exclusively to the feed coal to bunkers of Unit 5,6&7 respectively. These Shuttle Conveyors are playing very vital role to maintain the bunker levels for smooth generation of electricity (500MWx3). Shuttle conveyor moveable & reversible conveyor and travelled on rail track system provided below shuttle conveyor. The shuttle conveyor deck module consists of horizontal stringer channel with supporting steel angle bracing, conveyor frames, idlers, deck sheets, drive units, etc. These shuttle conveyors are in service commissioning i.e., 1992, 1993 & 1997. On thorough inspection of the deck module of shuttle conveyor, it is found that the deck channels and supporting bracing steel are badly corroded. This led to the misalignment of the shuttle conveyor which further led to the

running out problem of conveyor belts and coal spillage. Further rail track system also worn severely. Slipping problem also notice frequently as per records. In past repairing/replacement/strengthening of deck module/take up system/rail track system was done but problems still persist. Further it is noticed that bunker grills are made of mild steel material which are prone to erosion results in less life.

Considering long service life minimum 15 years, shuttle conveyor needs to be renovated and modernized for smooth running of coal handling plant for smooth generation by complete replacement of travel rail track system with modified system, modification of deck module by reducing load on shuttle gross weight, replacement of deck sheets, modified take up tensioning arrangement etc.

Hence considering smooth generation of electricity as per KRA target and to ensure the system runs to the maximum capacity for next minimum 15 years and to run the all the Units of 500MW as per KRA target., it is very much essential to taken up the work of Renovation & upgradation of Bunker Shuttle Conveyor with allied works on urgent basis in CHPB. For improving the life of bunker grills it is recommended to provide suitable layer of wear resistant material at top only.
