**INSPECTION OF DAMAGED /RUNNING/FAILED PARTS
CHPA/B/C of Unit 3 to7**

**M/s. CHANDRAPUR SUPER THERMAL POWER
STATION,MSPGCL,CHANDRAPUR**

***CENTRAL POWER RESEARCH INSTITUTE
THERMAL RESEARCH CENTRE,DHUTI– 441108,
DIST.-NAGPUR (M.S.)***

TEST REPORT NO. & DATE	: TRC/EMD/TOS-290/2022-23/FR Date 18.03.2023
CLIENT'S ADDRESS	: Chief Engineer, Chandrapur Super Thermal Power Station, Maharashtra State Power Generation Co. Ltd., Chandrapur. (M.S.)
WORK ORDER NO.	: email dtd. 03.03.2023
PARTICULARS OF COMPONENT INSPECTED	: Components CHPA/B/C of Unit 3 to7
PERIOD OF INSPECTION	: 16.03.2023-18.03.2023
PARTICULARS OF INSPECTION	: Inspection of damaged /running/failed parts at CHPA/B/C of Unit 3 to7
TEST IN ACCORDANCE WITH STANDARD/SPECIFICATION/ CLIENTS REQUIREMENT	: As per client's requirement.
DEVIATION IF ANY	: NIL
NUMBER OF PAGE	: 53 Pages.(Fifty Three pages only)

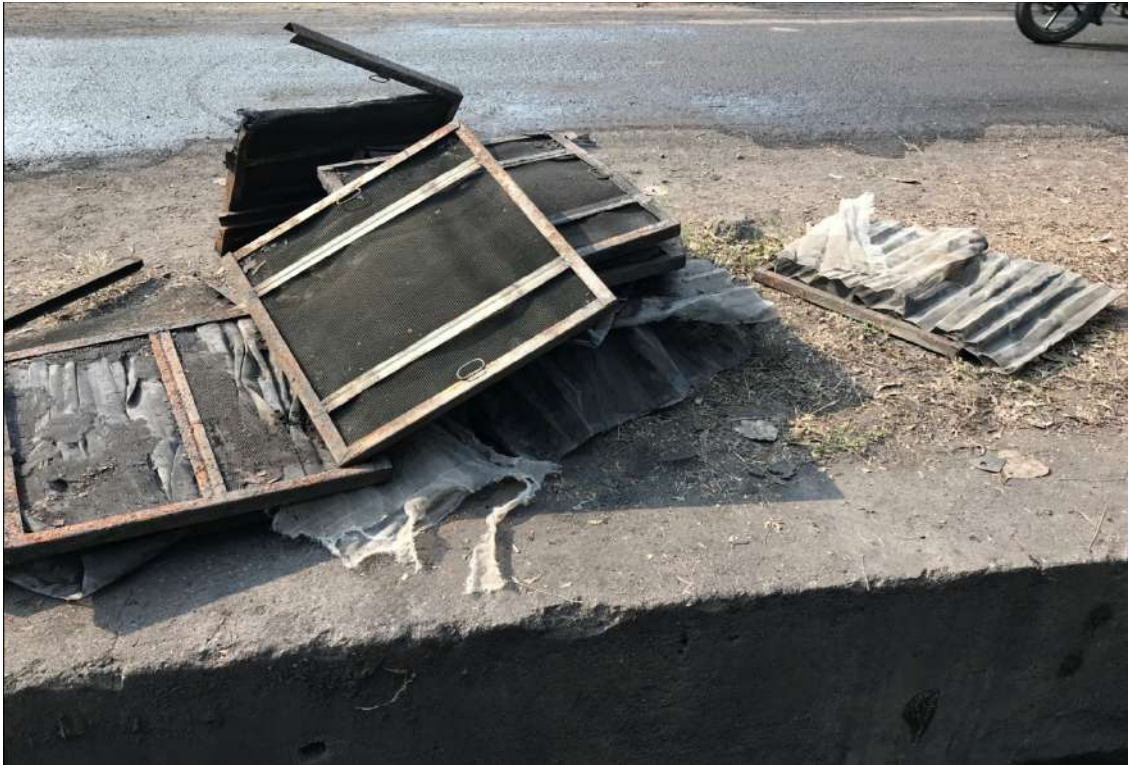
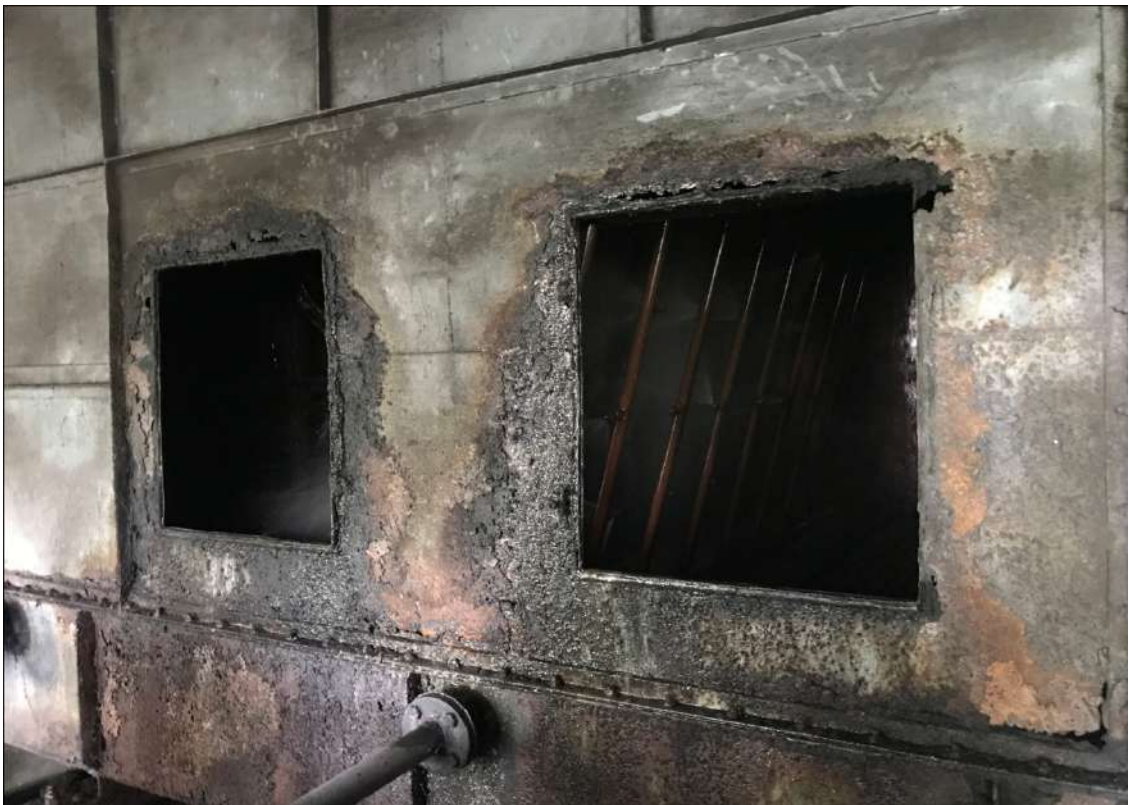
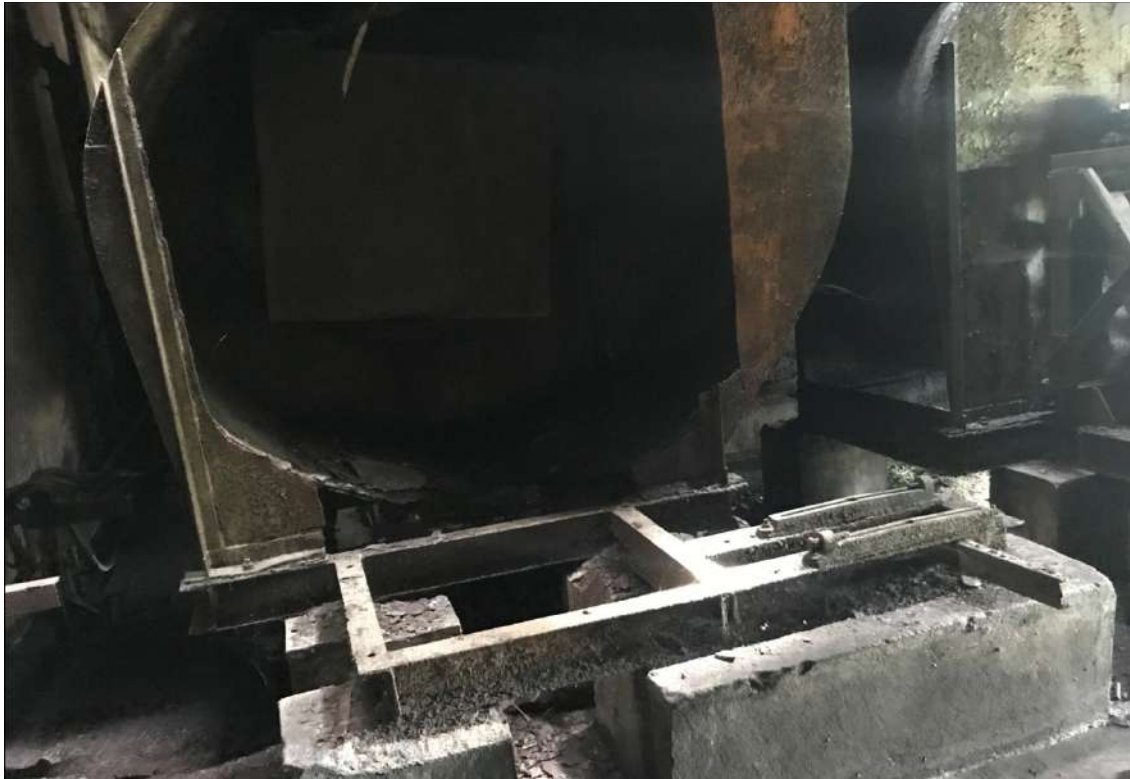
4.16 Dust Extraction System for Crusher House of CHP of Unit 3 to 7 and Energy Efficient Air-Cooling System for CHP of Unit 5,6&7

During operation activities of Coal Handling Plant considerable coal dust is generated at Crusher House. To control the emission of dust particle, the Dust Extraction system was provided during commissioning of coal handling plant. Since it is @ 25-30 years old system, it is not in service and unable to handle existing dust load at crusher house & bunker house. The existing dust suppression system is not sufficient to combat dust emission as per standard set by MPCB. Further, Environmental Pollution Control norms have been made more stringent and are observed very strictly which enforces to install new Dust Extraction system which control fugitive emission within prescribed limits of MPCB. As per records MPCB have served the show-cause notice for legal action to be taken against CSTPS under provision of Water (Prevention & Control of Pollution) Act, 1974 & Air (Prevention & Control of Pollution) Act, 1984.

Further Air-cooling system also known as ventilation system is provided at Wagon Tippler MCC room, Switchgear rooms in SS I & SS II & CHPC MCC room is badly damaged. These are beyond repairable need to be replaced with new energy efficient air temperature air cooling system with upgraded version. Available air-cooling system installed in CHPB/C are in service since commissioning and in past many times repairing, retrofitting, strengthening done but air-cooling system is not sufficient to maintain the conditioning temperature of MCC/Relay rooms.

It is recommended to install New Dust Extraction System to avoid human health hazard and penal action from MPCB.

Also, it is recommended for design, engineering and supply of new up graded version new energy efficient air temperature air cooling system.
